Baker Home Inspections

Client(s): **Sample Report**

Property address: **123 Anonymous St
Bellingham WA**

Inspection date: **Wednesday, January 9, 2019**

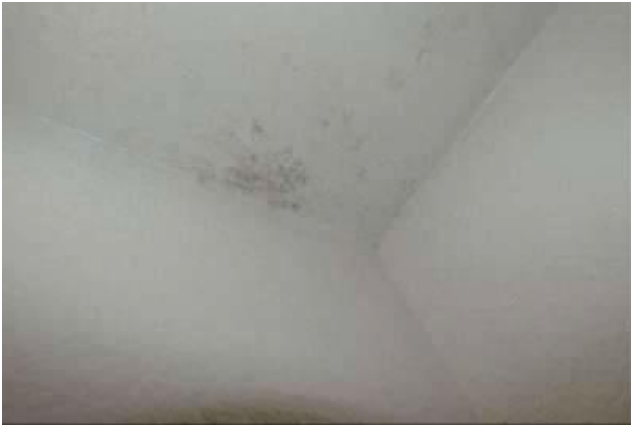
Microbial growths were found at two locations in interior rooms (the bathroom and the southwest bedroom. It is beyond the scope of this inspection to identify what substance or organism this staining is. However such staining is normally caused by excessively moist conditions, which in turn can be caused by plumbing or building envelope leaks and/or substandard ventilation. These conducive conditions should be corrected before making any attempts to remove or correct the staining. Normally affected materials such as drywall are removed, enclosed affected spaces are allowed to dry

Photo 3-1 Bathroom

thoroughly, a mildewcide may be applied, and only then is drywall reinstalled. For evaluation and possible mitigation, consult with a qualified industrial hygienist or mold/moisture mitigation specialist. For more information, visit:

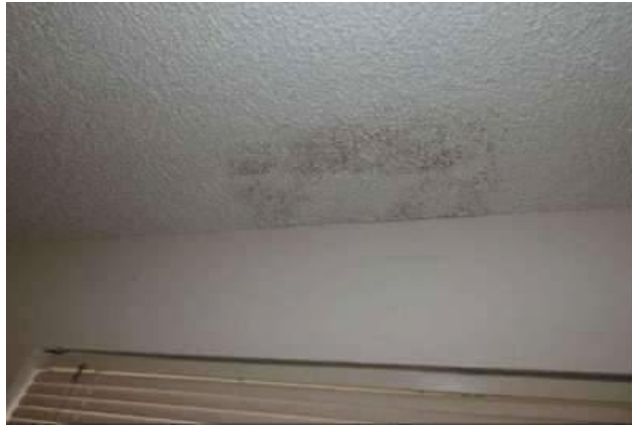
Photo 3-2 Southwest bedroom

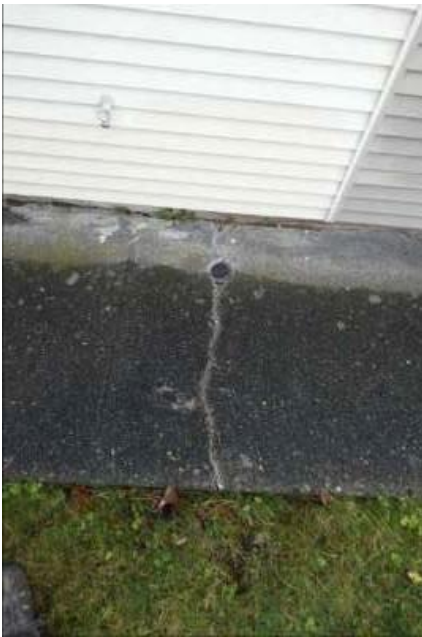
Photo 10-1

- 10) Minor deterioration (e.g. cracks, holes, settlement, heaving) was found in sidewalks or patios, but no trip hazards were found. The client may wish to have repairs made for cosmetic reasons.

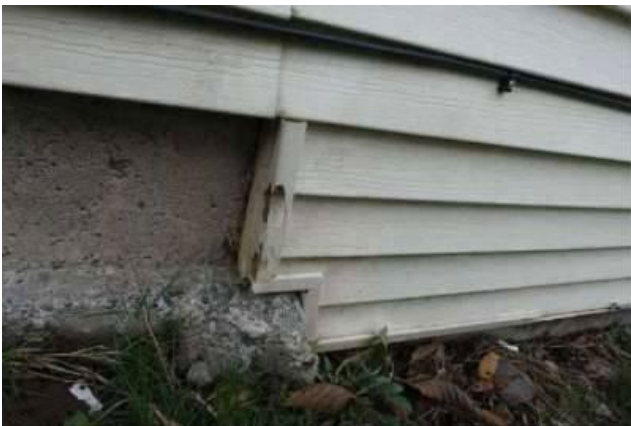
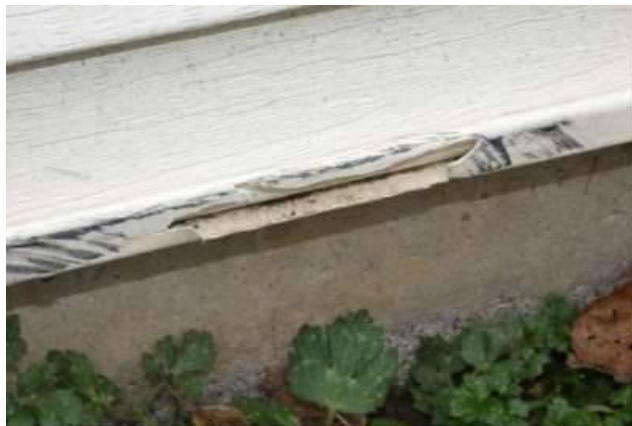
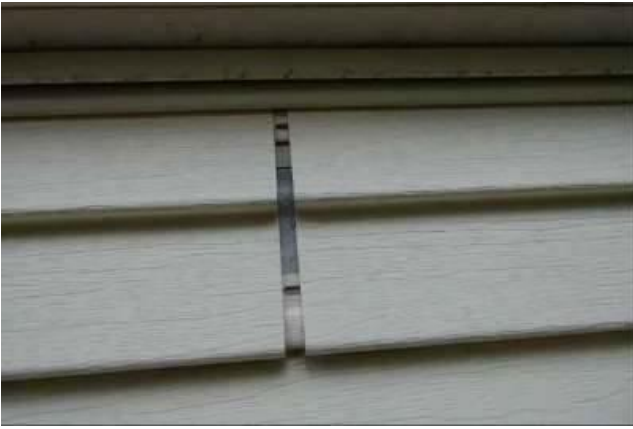
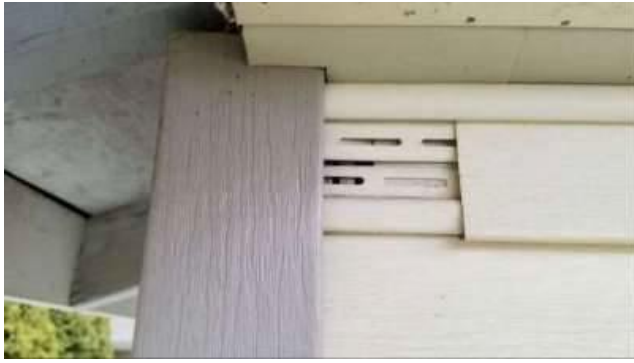
Some sections of siding and/or trim were loose, damaged and/or substandard. Recommend that a qualified person repair, replace or install siding or trim as necessary.

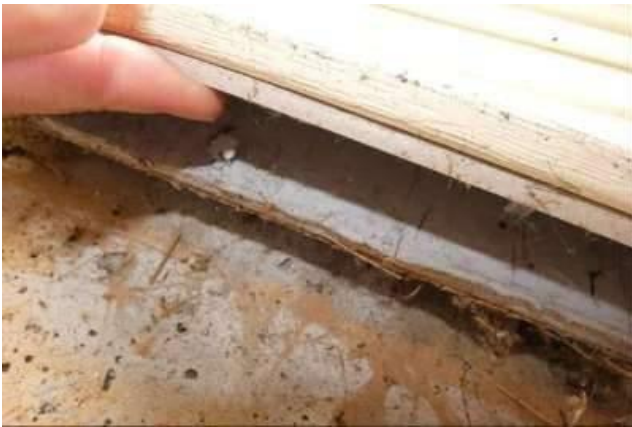
Photo 19-1

19) The home had two or more layers of siding installed. Issues that may exist are: possible hidden rot, moisture issues, fasteners for vinyl siding not being adequate, concealed flashing issues. It is outside the scope of a standard home inspection to know if any of these issues are present. Recommend further evaluation and repair or replace as necessary by qualified contractor.

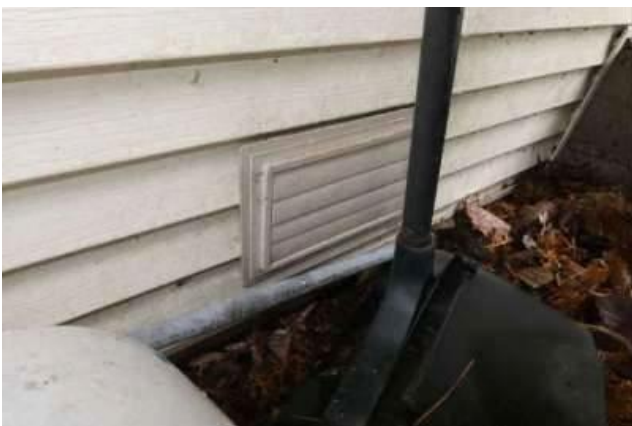
Photo 22-1

22) **i** The crawl space vents were intentionally blocked (e.g. removable panels, rigid foam). This restricts ventilation in the crawl space and can result in increased levels of moisture inside. This is a conducive condition for wood-destroying organisms. Such vents should be left open at all times except during severe freezing weather. Recommend removing materials or items blocking vents as necessary.

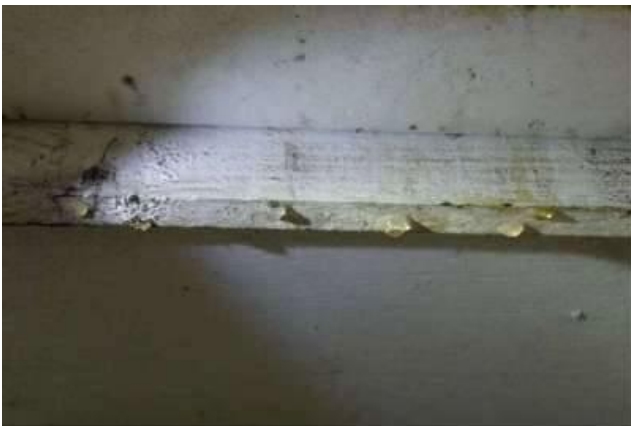
Photo 25-1

Water was leaking behind a many gutters. Rainwater can come in contact with the building exterior or accumulate around the foundation as a result. The edge of the roof structure may become damaged by rot or water. This is a conducive condition for wood-destroying organisms. Recommend that a qualified person evaluate and repair as necessary. For example, by installing flashing or tightening loose gutters.

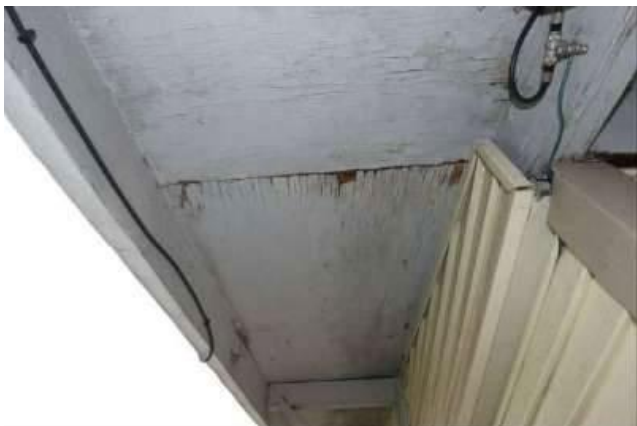
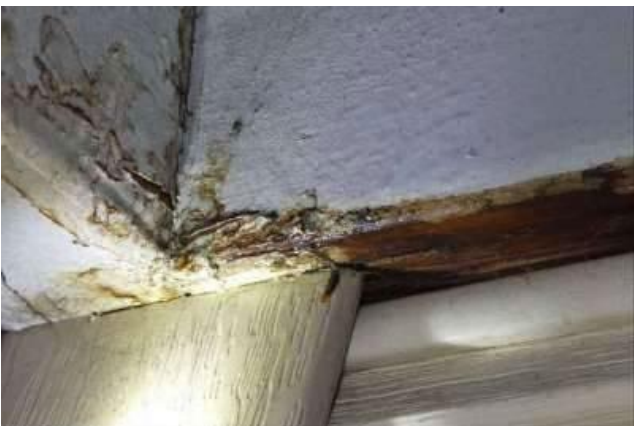
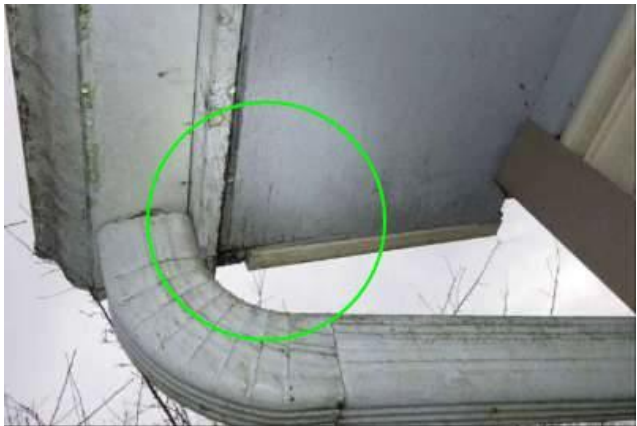
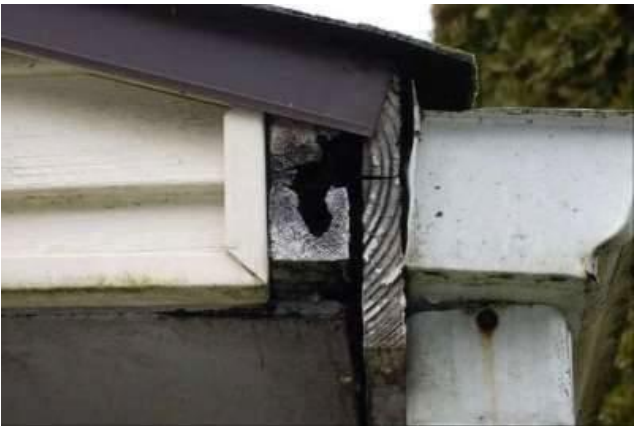
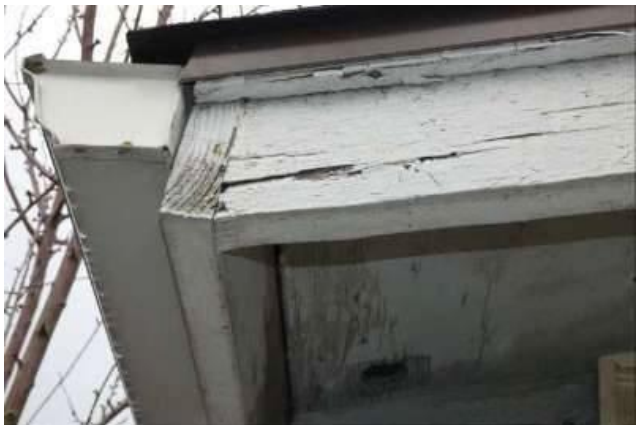
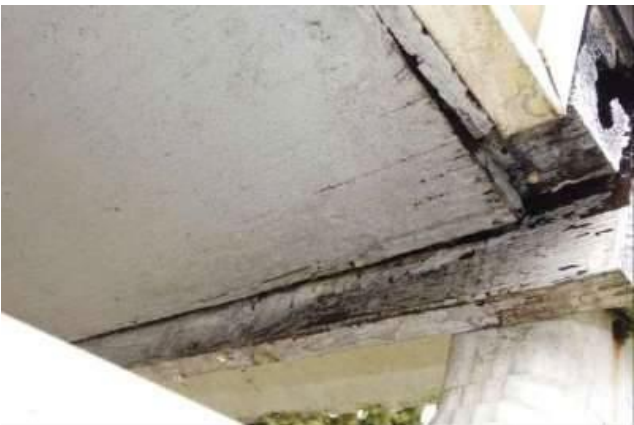
Fungal rot or significant water damage was found at some roof areas at edges of roof sheathing, barge boards and/or soffits. Recommend that a qualified contractor repair as necessary. For example, by replacing all rotten wood, priming and painting new wood and installing flashing.

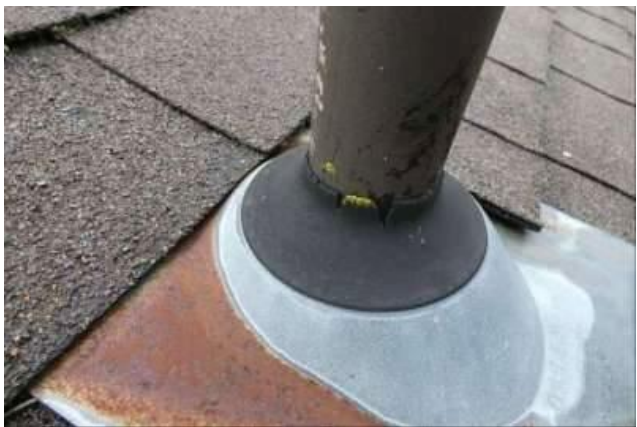
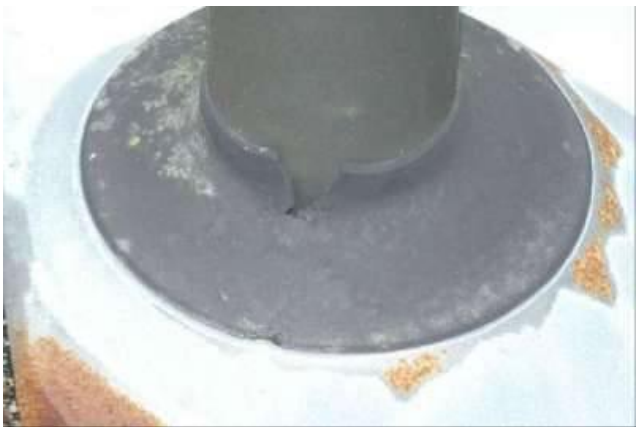
The rubber or neoprene pipe flashings were split or cracked. Leaks can occur as a result. This is a conducive condition for wood-destroying organisms. Recommend that a qualified contractor replace flashings where necessary.

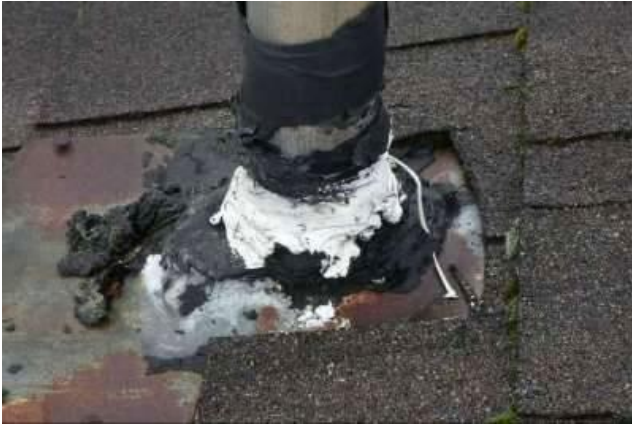
Photo 28-3 Oh, it is split? Just throw a bunch of caulk on it.

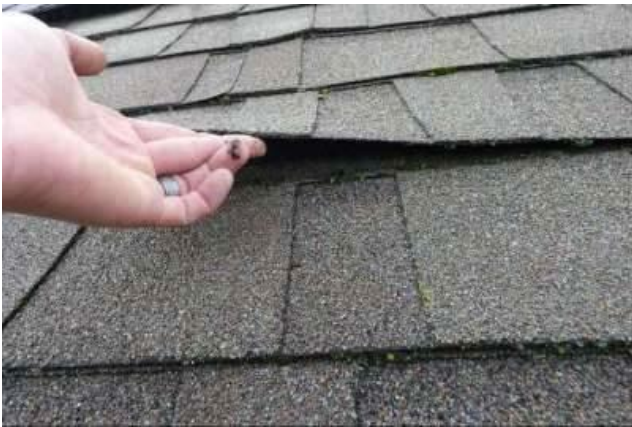
Photo 30-1

Composition shingles were loose because the adhesive, self-sealing strips weren't sealed. Leaks can occur as a result. This is a conducive condition for wood-destroying organisms. Self-sealing strips secure the lower edge of shingles and reduce vulnerability to wind damage. Strips may not be sealed because the sealant has failed or because the sealant never activated and cured after the original installation. Recommend that a qualified contractor repair as necessary. For example, by hand sealing shingles with an approved sealant.

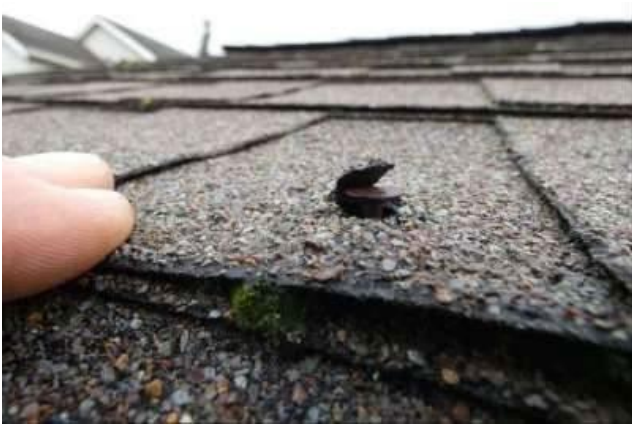
Photo 31-1

Some roofing nails or staples were loose, resulting in holes in shingles, loose shingles or lifting shingles. Leaks may occur and can be a conducive condition for wood-destroying organisms. Recommend that a qualified contractor repair as necessary.

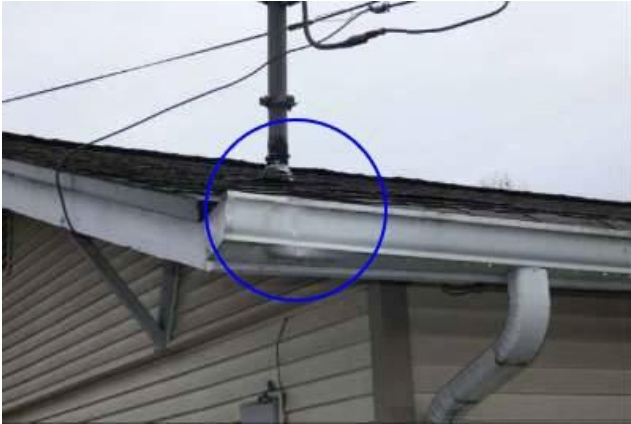
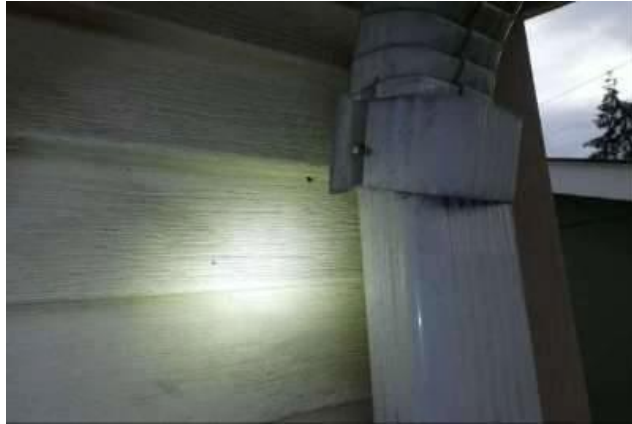
33) A few gutters and/or downspouts were loose and/or damaged. Rainwater can come in contact with the building exterior or accumulate around the building foundation as a result. This is a conducive condition for wood-destroying organisms. Recommend that a qualified person repair as necessary.

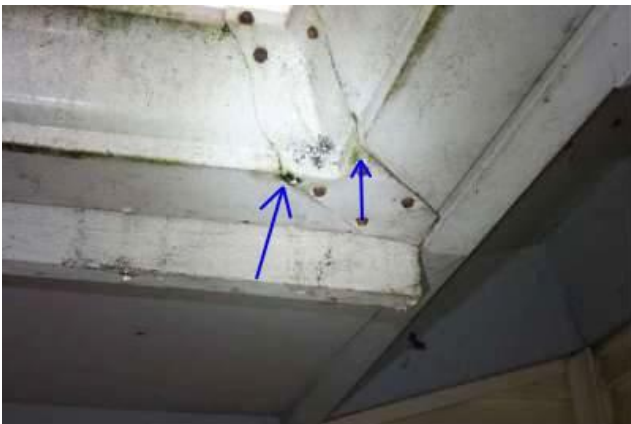
Photo 34-1

34) Some gutters were leaking. Rainwater may come in contact with the building exterior or accumulate around the foundation as a result. This is a conducive condition for wood-destroying organisms. Recommend that a qualified person repair as necessary.

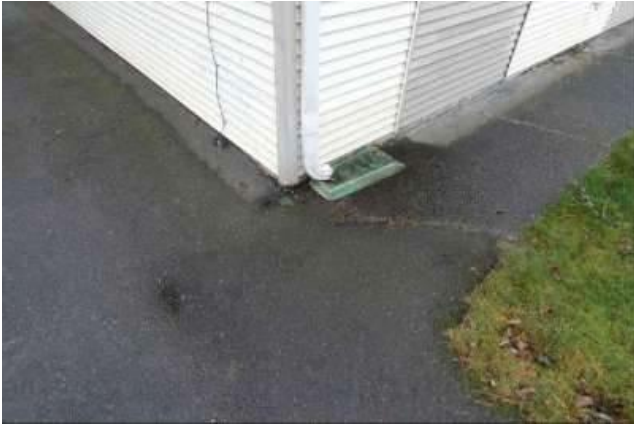
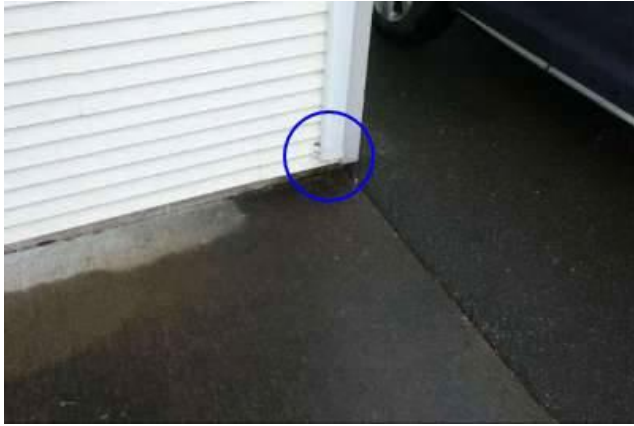
36) Extensions such as splash blocks or drain pipes for the downspouts were missing and/or poorly sloped. Water can accumulate around the building foundation or inside crawl spaces or basements as a result. Recommend that a qualified person install, replace or repair extensions as necessary so rainwater drains away from the structure.

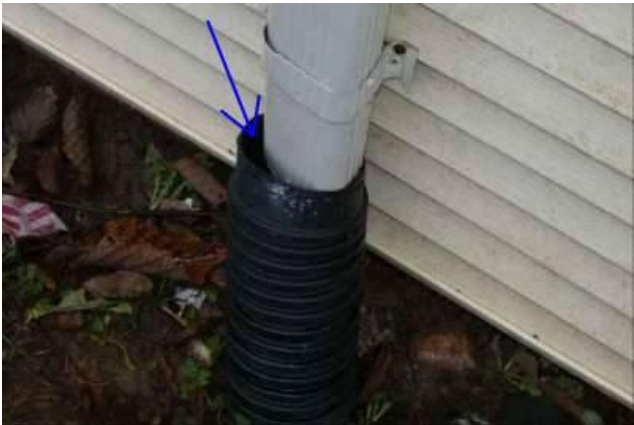
Photo 37-1

37) 🛠️ There was a gap between a couple downspouts and the drain lines. This can allow debris to enter the drain line which can result in clogged lines. Recommend repair by qualified party.

Here is an example of a solution to this concern: <https://www.lowes.com/pd/4-in-dia-PVC-Adapter-Fitting/3133141>

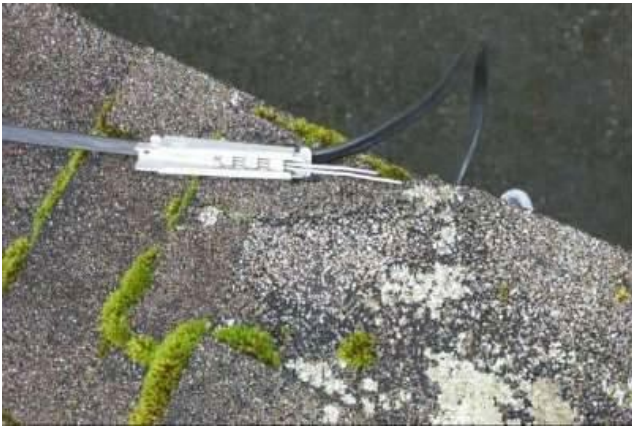
Photo 42-1

A low voltage wire was making contact with some shingles. This has already caused some damage. Recommend further evaluation and repair or replace as necessary by qualified contractor.

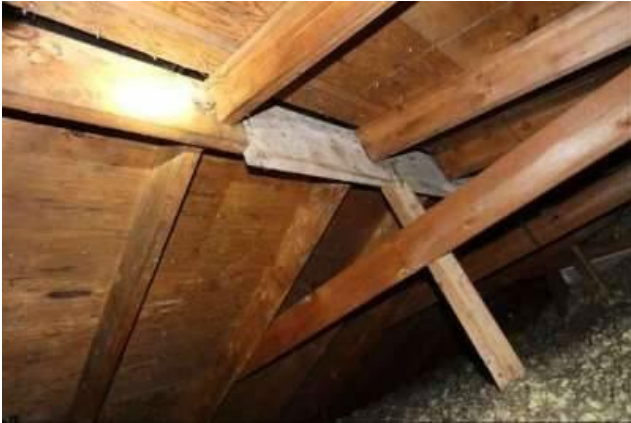
Photo 44-1

Substandard construction methods observed at a couple locations in the west attic space. This is a potential safety hazard. Recommend further evaluation and repair or replace as necessary by qualified contractor

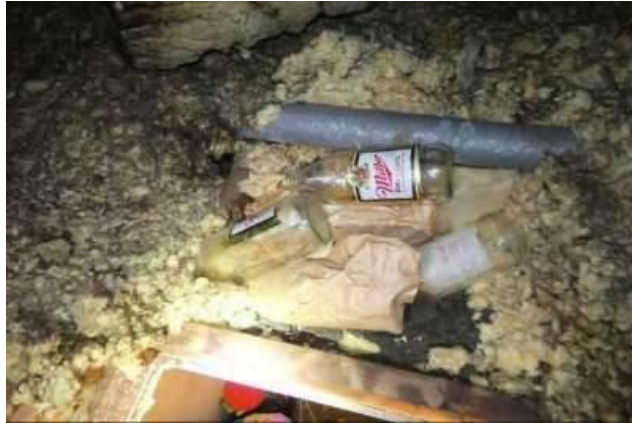
Photo 44-2 Maybe these were to blame

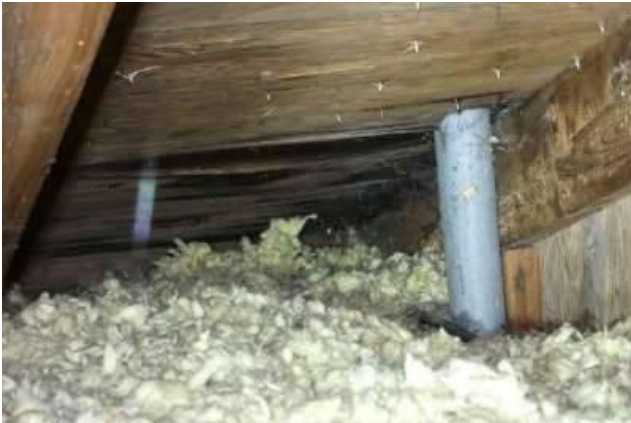
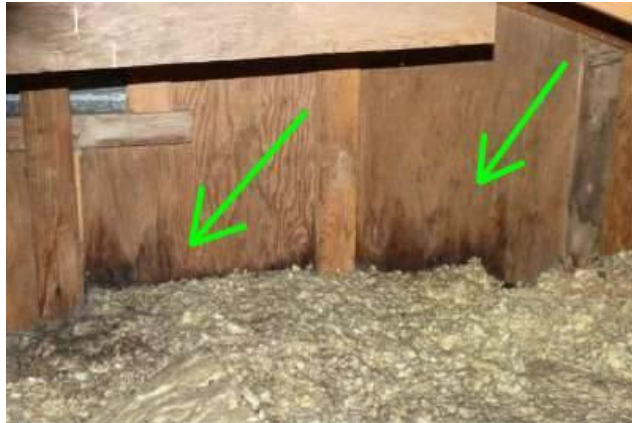
The roof structure in the attic was wet, and/or dripping water was found at the northwest corner of the west attic. There appeared to be one or more active leaks in the roof. Recommend that a qualified contractor evaluate and repair as necessary.

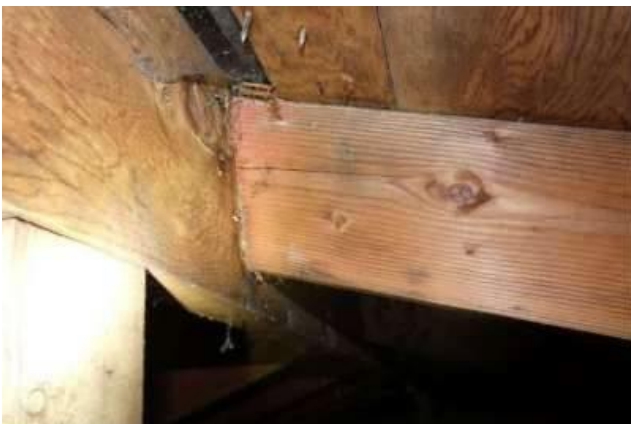
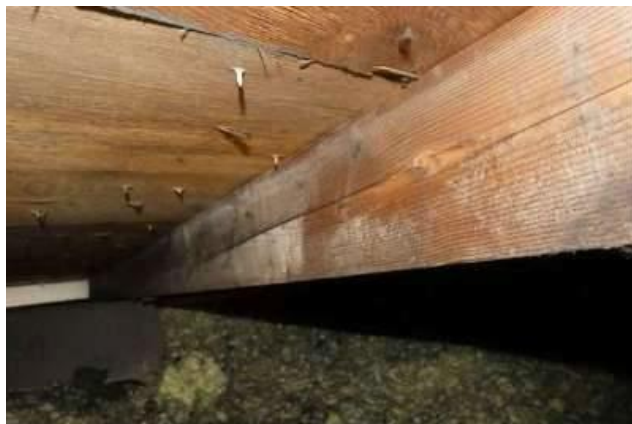
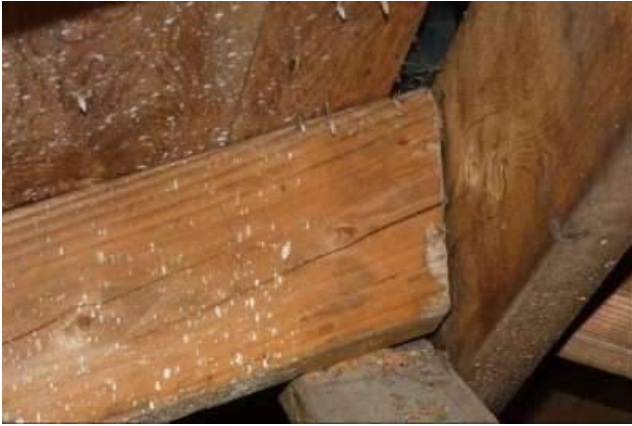
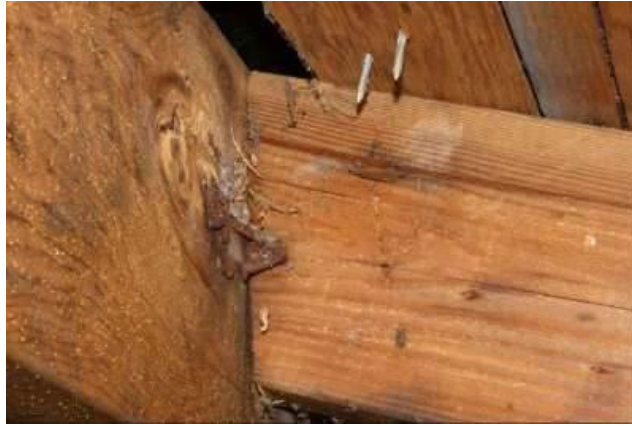
Some rafters in the roof structure were damaged or split. This may significantly weaken the roof structure. Recommend that a qualified contractor evaluate and repair or replace as necessary.

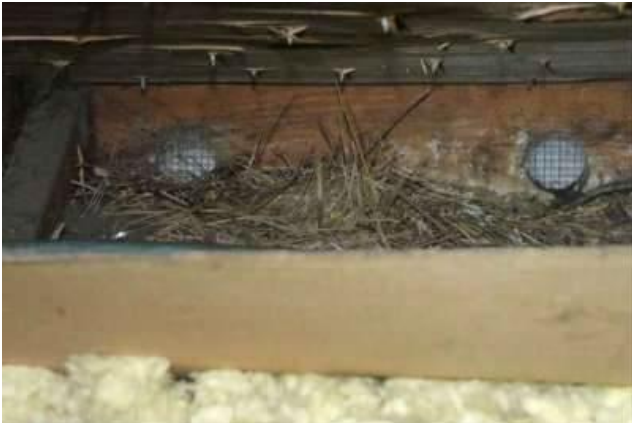
**Photo 49-1**

A couple animal (e.g. bird, squirrel) nests were found in the attic. Nesting materials should be removed. Surrounding insulation should be repaired or replaced if necessary. Holes or openings into the attic (e.g. screens, gaps) should be repaired as necessary by a qualified person to prevent future nesting or vermin intrusion.

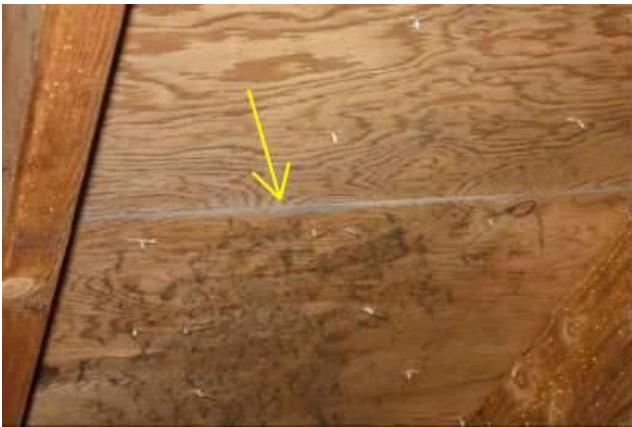
Photo 52-1

52) Roof sheathing (plywood or oriented strand board) was sagging in some areas and no panel edge clips ("H clips") were installed. These should be installed when truss or rafter spacing is 24 inches o.c. or more and with 3/8-inch sheathing. These clips help support the edges of the sheathing, and sagging can result if they're not installed. This may also void the warranty on some brands of shingles. Recommend that a qualified contractor evaluate and repair per standard building practices.

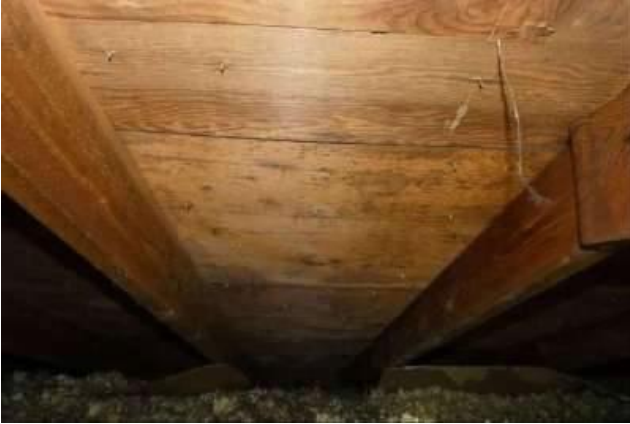
Photo 55-1

Note that the inspector is not a mold specialist or industrial hygienist and provides no professional opinion on health issues related to microbial growth.

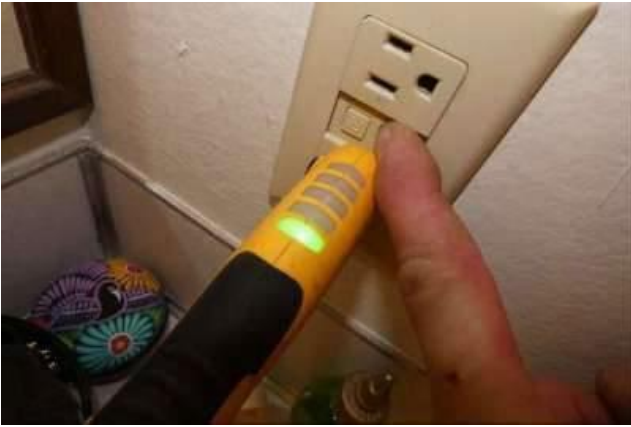
**Photo 56-1**

The ground fault circuit interrupter (GFCI) devices protecting receptacles at the bathroom wouldn't trip when tested. This is a potential shock hazard. Recommend that a qualified electrician evaluate and repair as necessary.

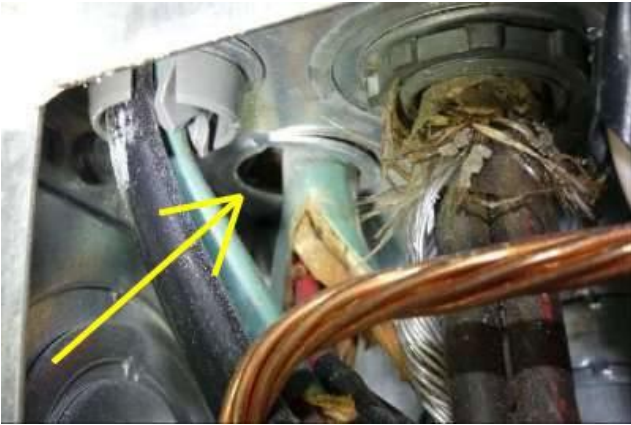
**Photo 57-1**

One bushing was missing or loose from where wires enter the hole in the service panel. This is a potential safety hazard because the wiring insulation can be cut or abraded on the metal edge of the hole. Recommend that a qualified electrician install or repair bushings where necessary.

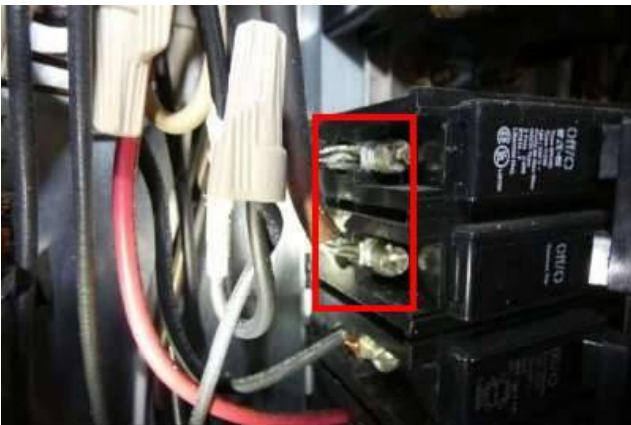
**Photo 58-1**

Two multi-strand aluminum wires in the service panel lacked anti-oxidant paste at their connections with other equipment (e.g. circuit breakers, lugs, bus bars). Oxidation can occur without it and result in reduced conductivity and overheating. This is a potential fire hazard. Recommend that a qualified electrician apply anti-oxidant paste per standard building practices.

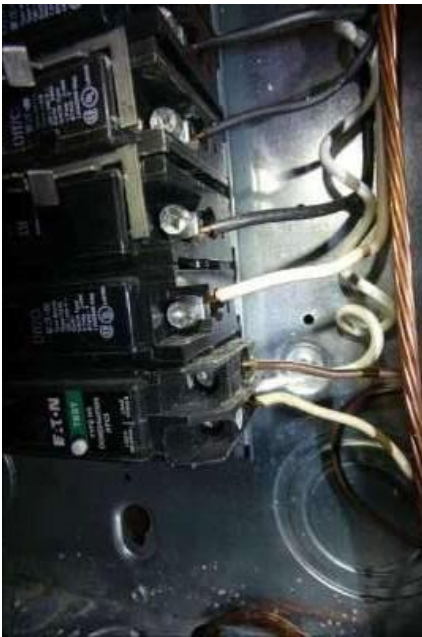
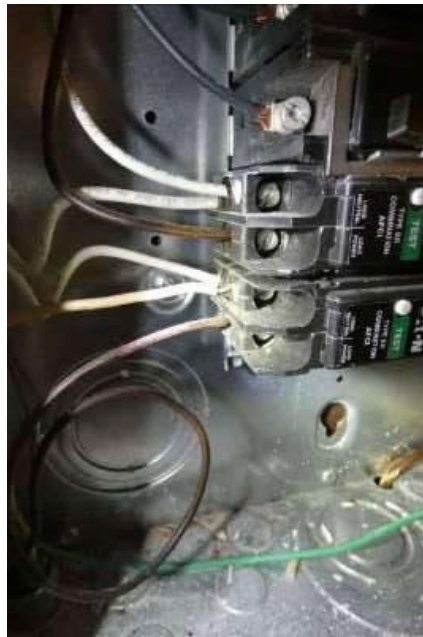
A few energized conductors in the service panel had white or brown insulation. Insulation on energized conductors should be black or red in color to identify them as energized wires. Recommend that a qualified electrician re-identify wires per standard building practices. For example, by wrapping in black vinyl tape or marking with a black permanent marker.

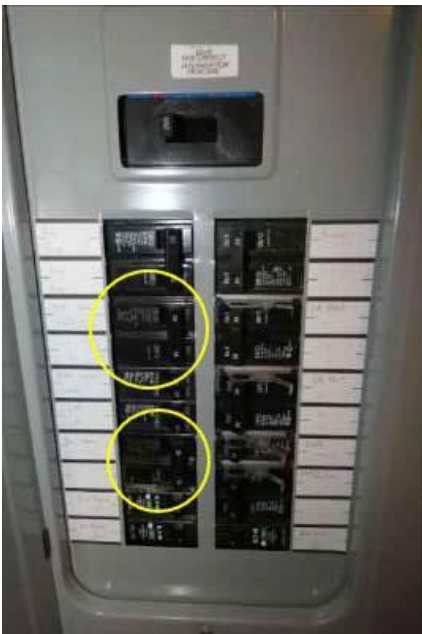
Unapproved breakers were installed in the service panel. Some breakers made by other manufactures are allowed in certain panels, however these are not. Recommend further evaluation and repair or replace as necessary by licensed electrician.

Photo 72-1 Only Cutler-Hammer breakers with "BR" on labeled them are allowed; these are labeled "CL".

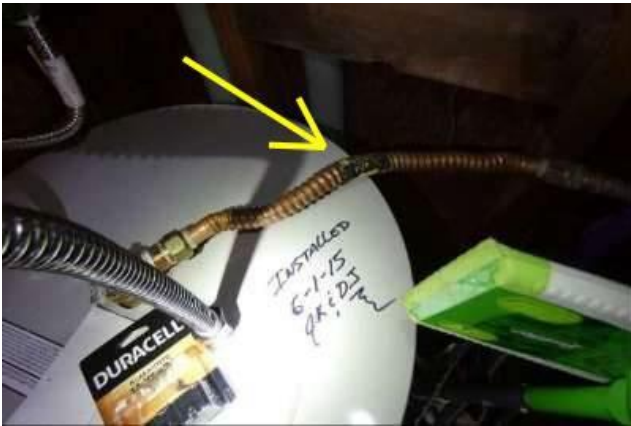
Photo 79-1

79) + One flexible connector was used for the temperature-pressure relief valve drain line. Flex connectors can be bent or kinked so as to restrict the flow of the drain line and impair the operation of the valve. They typically are not rated for the temperature and pressure of water being discharged (potentially 150 psi and 210 degrees F). Flex connectors used this way pose a potential safety hazard for explosion. Recommend that a qualified plumber repair per standard building practices. For example, by installing a drain line made of rigid copper or CPVC plastic pipe.

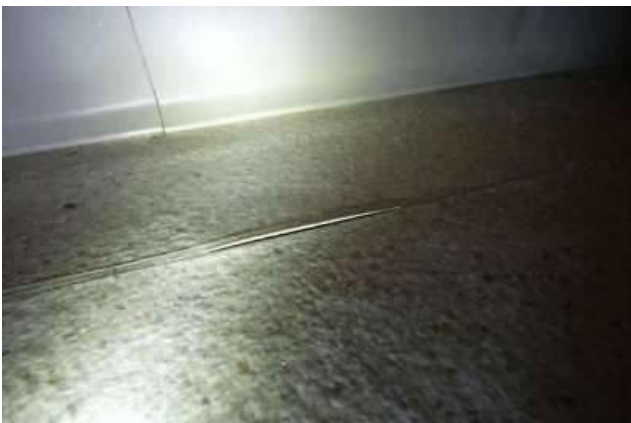
Photo 86-1

Vinyl flooring in the bathroom was deteriorated and/or loose. Water can damage the sub-floor as a result. Recommend that a qualified contractor replace or repair flooring as necessary.

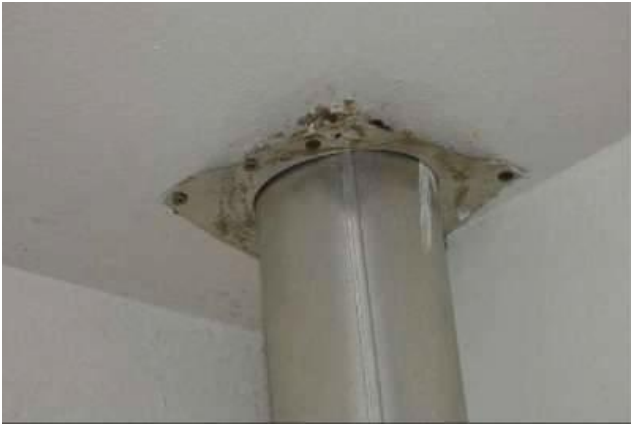
Photo 95-1

The dryer duct transition piece was loose and substandard. Recommend replace by qualified party.

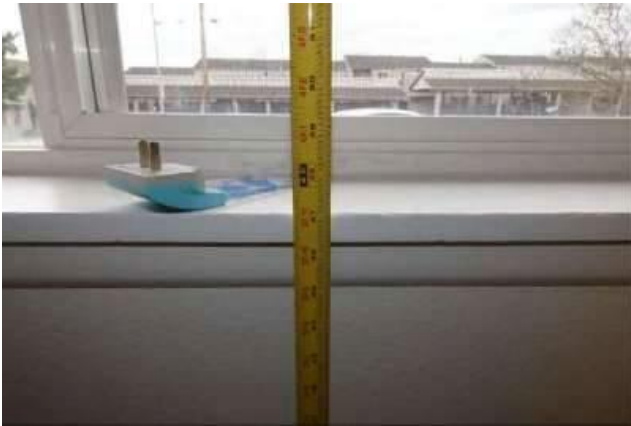
Photo 98-1 47 inches high

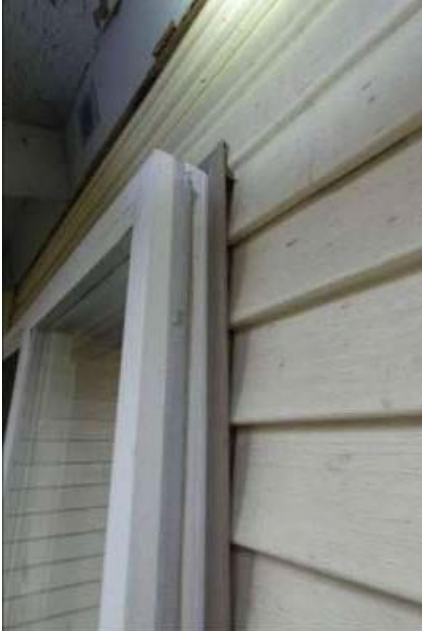
Photo 99-1

99) 🔧🔍 Less than professional installation of the vinyl windows. Leaks can occur as a result creating a conducive condition for wood-destroying organisms. Recommend further evaluation and repair or replace as necessary by qualified contractor.

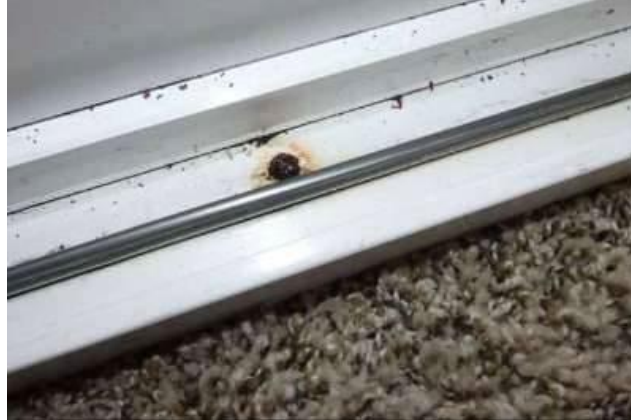
Photo 99-2 Moisture is collecting in the tracks and causing fasteners to rust.

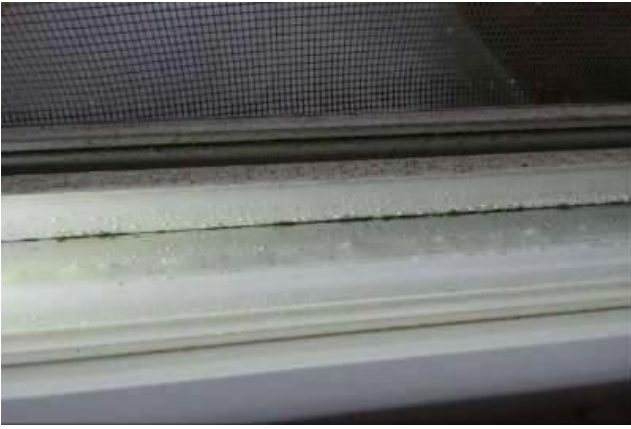
Photo 99-3 Moisture is being retained in the window track rather than exiting through the wep holes.

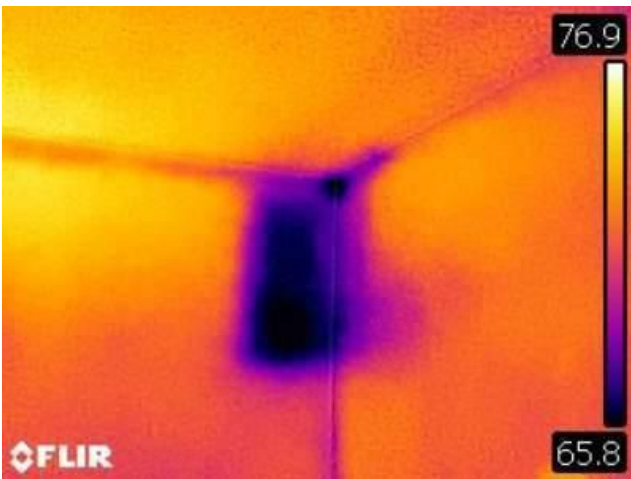
Photo 110-1 East wall in living room

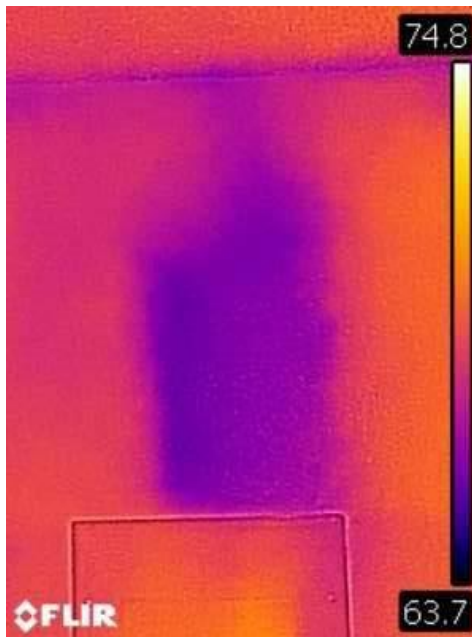
Photo 110-2 Above the service panel
