Baker Home Inspections

Client(s): **Future Home Owner**
Property address: **123 Baker Street**
Bellingham, WA
Inspection date: **Thursday, December 13, 2018**

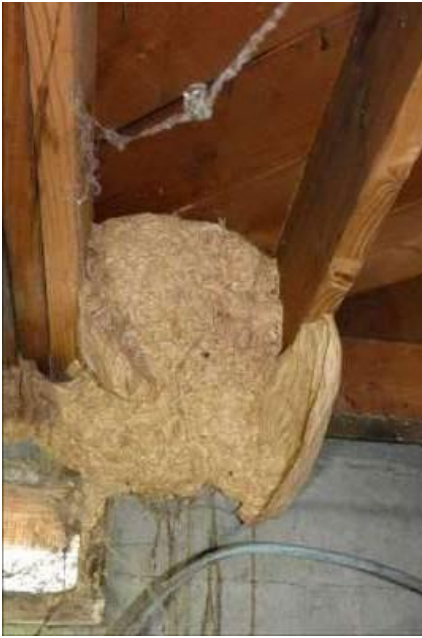
A few hornet, bee or wasp nests were found at the building exterior and in the crawl space. These can pose a safety hazard. A qualified person should remove nests or exterminate as necessary.

Photo 1-1 Southwest corner of crawl space.

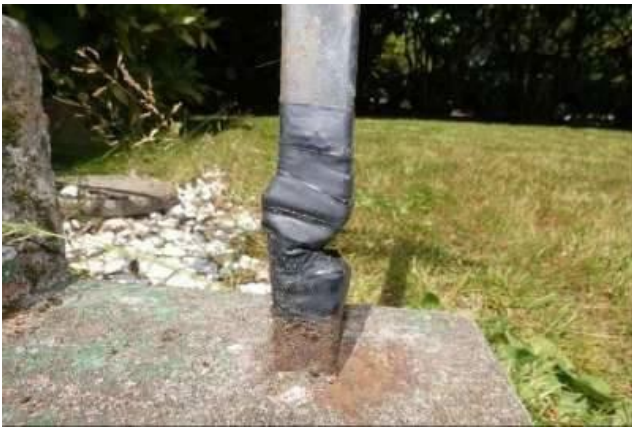
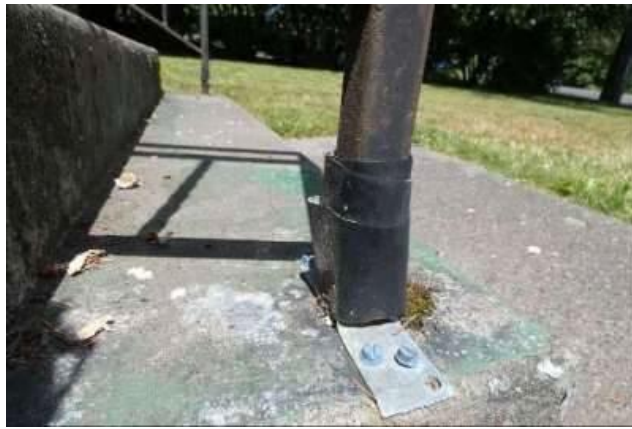
Handrails at the flights of stairs were loose and/or wobbly. This is a safety hazard. Recommend that a qualified person repair as necessary.

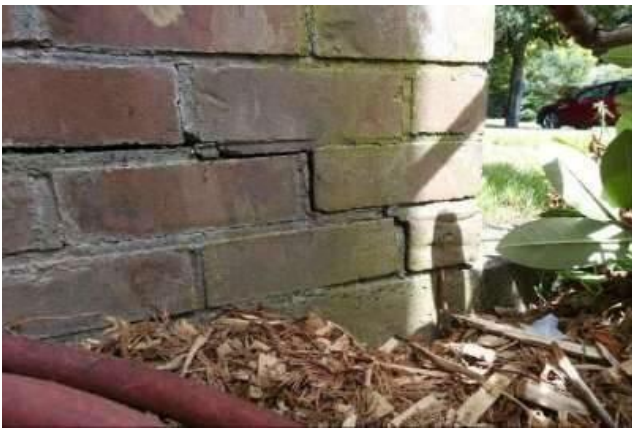
Photo 10-1

- 10) **⚠** The masonry planters were damaged and/or deteriorated. Recommend that a qualified person remove, repair or replace planters as necessary.

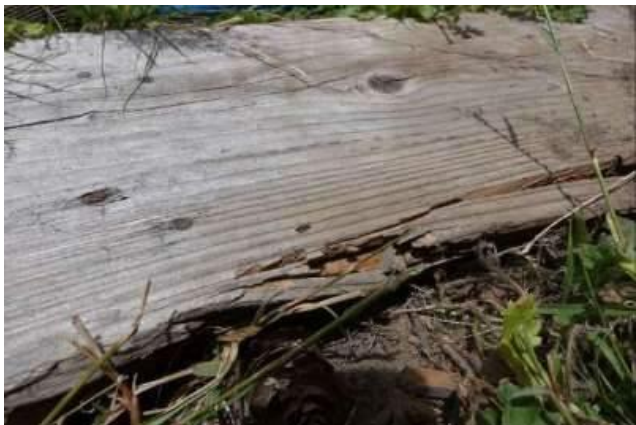
Photo 11-1

Fungal rot or damage from wood-destroying insects was found at the wooden planter boxes. Recommend that a qualified person remove, repair or replace planter boxes as necessary. All rotten or insect-damaged wood should be replaced or removed.

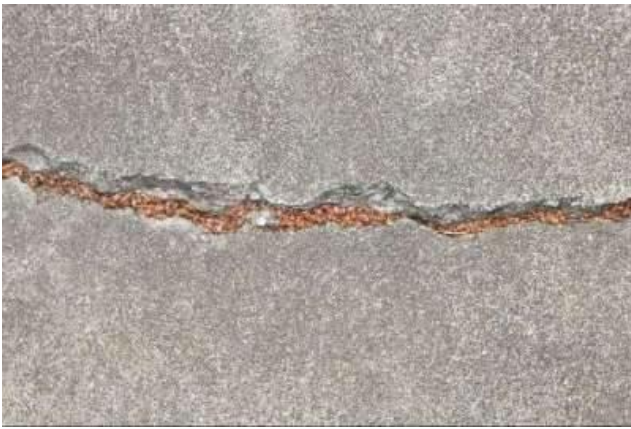
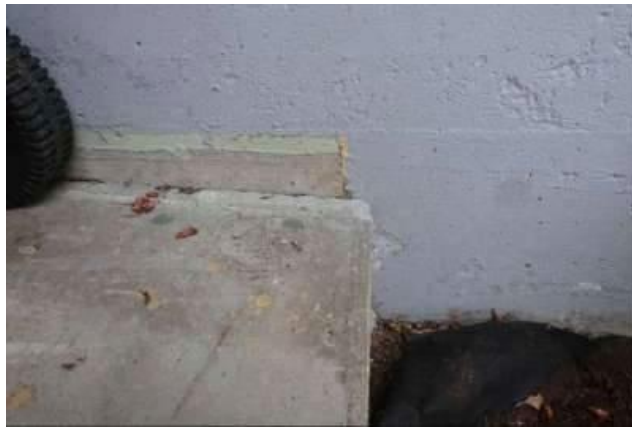
Cracks, holes, settlement, heaving and/or deterioration were found in the back patio. Recommend that qualified contractor repair as necessary.

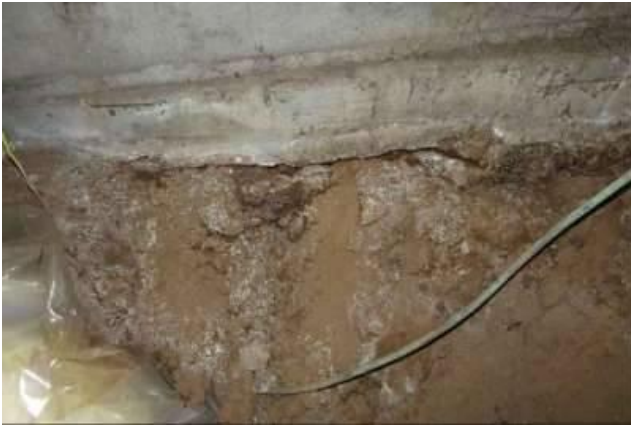
Photo 19-1

19) A couple isolated footings or sections of footings or foundations were undermined. Soil has either eroded out from underneath or has been excavated too close to these areas. Standard building practices typically require undisturbed soil to extend at least a foot horizontally out from the edge of footings and then slope down no more steeply than 45 degrees. Otherwise soil can collapse from beneath the footing(s). Recommend that a qualified contractor or engineer evaluate and determine what repairs if any should be made. If repairs are needed, a qualified contractor should make them.

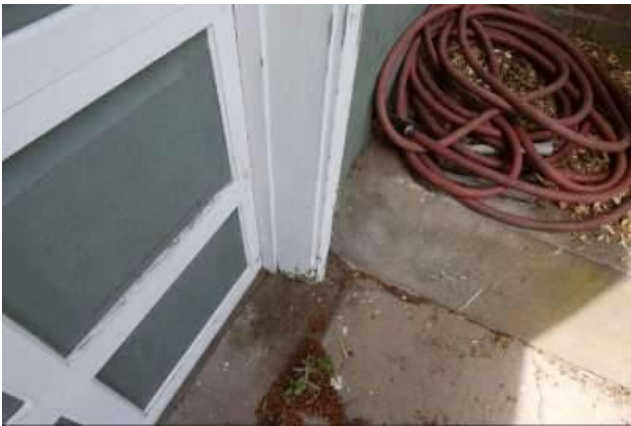
Photo 20-1

Untreated wood siding and/or trim was in contact with concrete or masonry at the exterior. Moisture collected between the two materials or wicking up into the wood is a conducive condition for wood-destroying organisms. Wood siding or trim should be installed with a minimum clearance of 1-2 inches between it and concrete or masonry below it at building exteriors. Monitor these areas for rot or infestation in the future and repair if needed. Recommend that a qualified person repair per standard building practices. For example, by trimming siding or trim as needed.

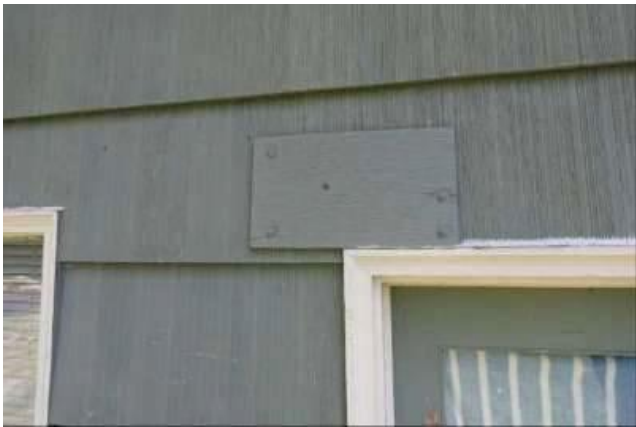
Photo 22-8

Many sections of siding and/or trim were deteriorated, split, warped, damaged, and/or substandard. Recommend that a qualified person repair, replace or install siding or trim as necessary.

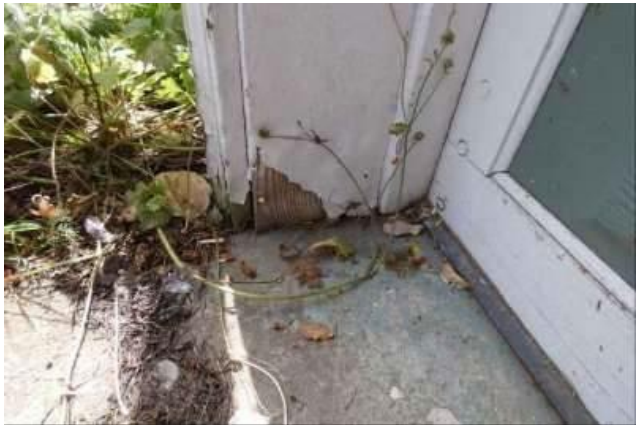
23) 🪛 Fungal rot was found at sections of siding, trim, window sills, fascia and, barge boards. Conductive conditions for rot should be corrected. Recommend that a qualified contractor repair as necessary. All rotten wood should be replaced.

Photo 23-1 Garage door

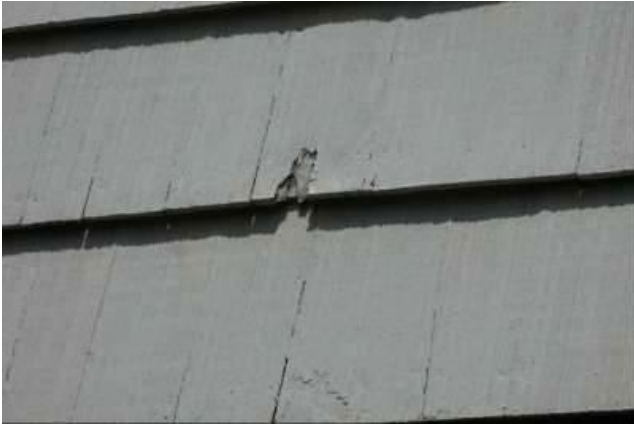
Photo 26-1

A few holes or gaps were found in siding or trim. Vermin, insects or water may enter the structure. Recommend that a qualified person repair as necessary.

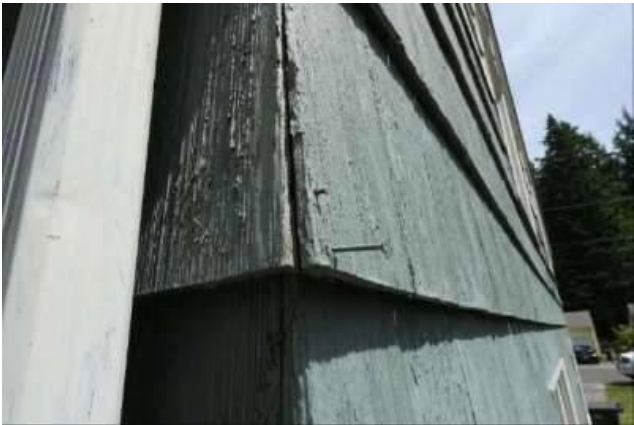
Flashing at a few locations was missing. Leaks can occur as a result. Recommend that a qualified person repair, replace or install flashing as necessary, and per standard building practices.

Photo 27-1 Missing corner flashing

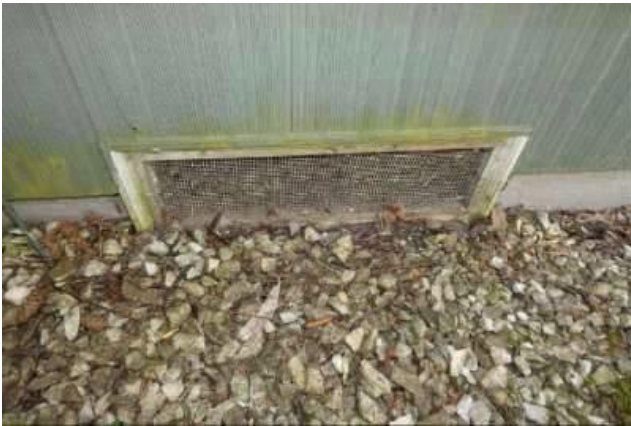
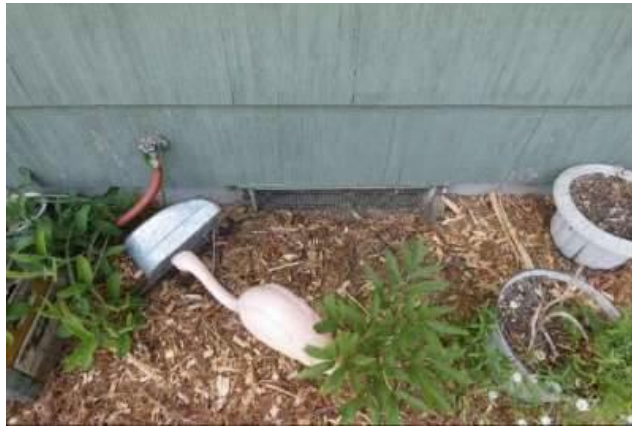
40) A few crawl space vents were at or below grade and either no wells were installed or wells were substandard. Vent wells should be installed when vents are at or near grade to prevent debris from blocking vents and/or water from entering vents. This is a conducive condition for wood-destroying organisms. Recommend that a qualified person install, replace or repair vent wells per standard building practices.

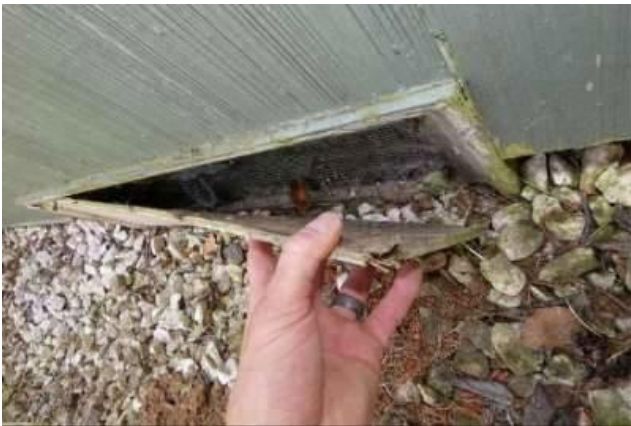
Photo 46-1

A couple crawl space vents were intentionally blocked. This restricts ventilation in the crawl space and can result in increased levels of moisture inside. This is a conducive condition for wood-destroying organisms. Such vents should be left open at all times except during severe freezing weather. Recommend removing materials or items blocking vents as necessary.

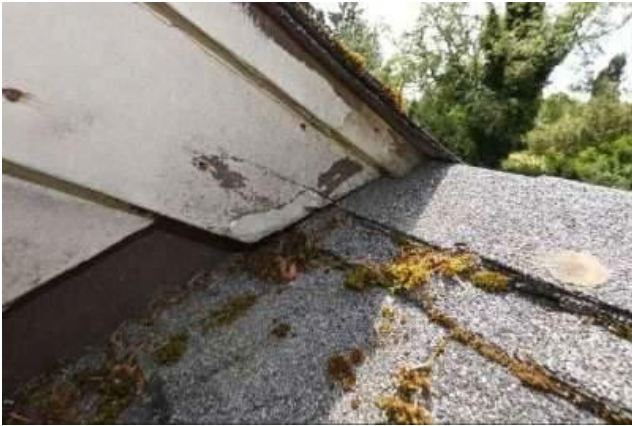
Photo 48-1

Structural or trim wood such as rafters or fascia boards were in contact with or too close to roof surfaces below. This is a conducive condition for wood-destroying organisms. There should be a gap of 1 1/2 to 2 inches between a roof surface and structural or trim wood above. The gap is meant to prevent water from wicking up into the bottom edge of the wood and causing fungal rot, or damaging the wood. There may also be inadequate space for additional layers of roofing materials in the future. Recommend that a qualified contractor repair per standard building practices. For example, by trimming the wood.

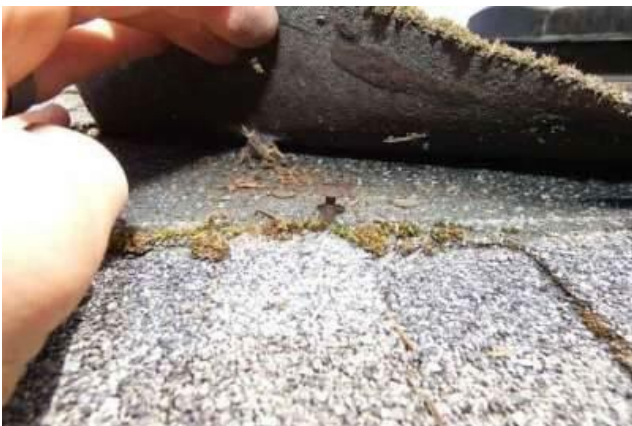
Photo 49-1

Some roofing nails or staples were loose, resulting in holes in shingles, loose shingles or lifting shingles. Leaks may occur and can be a conducive condition for wood-destroying organisms. Recommend that a qualified contractor repair as necessary.

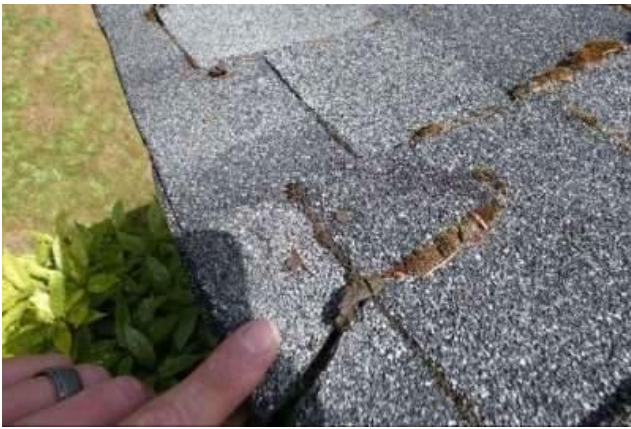
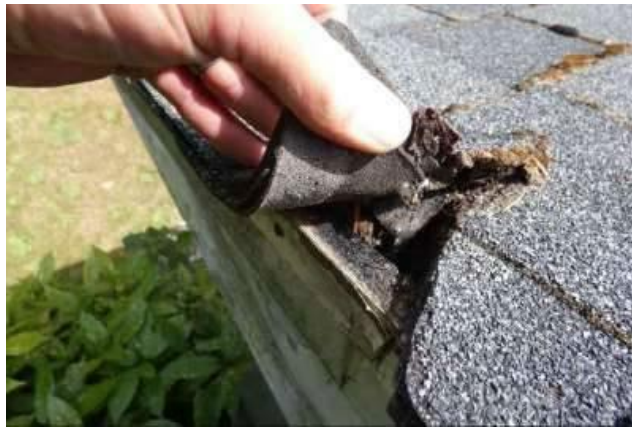
A couple composition shingles were damaged. Leaks can occur as a result. This is a conducive condition for wood-destroying organisms. Recommend that a qualified contractor repair as necessary. For example, by replacing shingles.

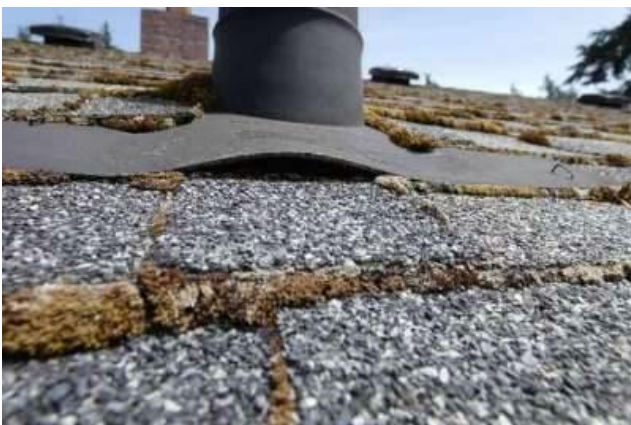
Photo 53-1

53) A couple rubber or neoprene pipe flashings were starting to lift. Leaks can result from windblown rain. This is a conducive condition for wood-destroying organisms. Recommend that a qualified person repair as necessary to prevent leaks. For example, by nailing flashings down and sealing as necessary.

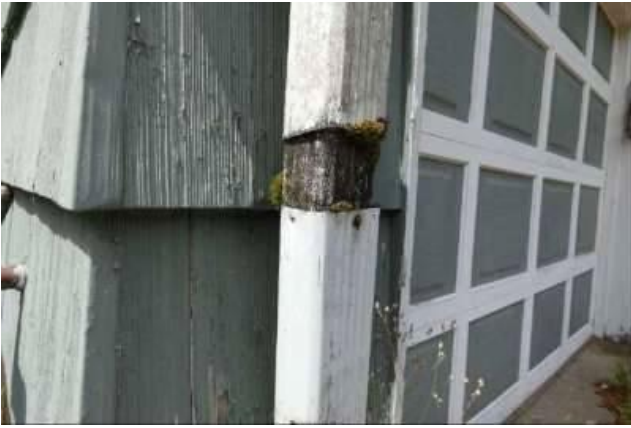
Photo 55-1

A few downspouts or elbows were loose, detached, or had a substandard installation. Rainwater can come in contact with the building exterior or accumulate around the foundation as a result. This is a conducive condition for wood-destroying organisms. Recommend that a qualified person repair as necessary.

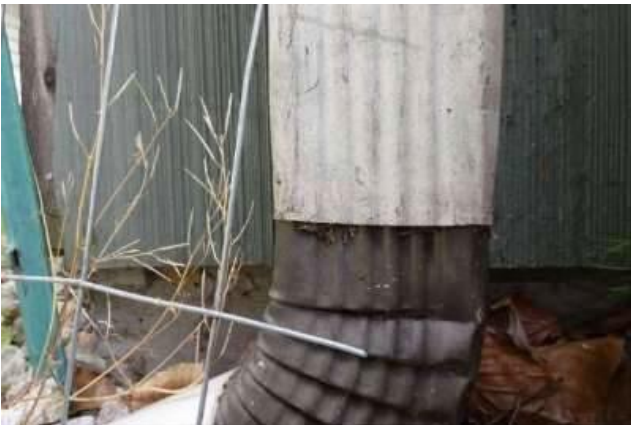
One downspout or elbow was installed incorrectly (upside down), with seams oriented so water will leak when flowing down through them. Rainwater can come in contact with the building exterior or accumulate around the foundation as a result. This is a conducive condition for wood-destroying organisms. Recommend that a qualified person repair as necessary.

Photo 56-1 Northwest corner

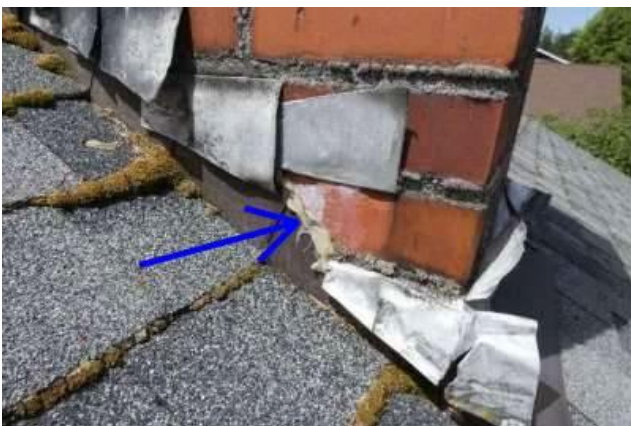
Photo 58-1

58) Sealant was used at one roof penetration (e.g. pipes, vents, chimneys) rather than flashing. Sealant is not required for most roof penetrations when installations of such items are done professionally and per standard building practices. The presence of sealant suggests that work was performed by someone who was not a qualified contractor. The sealant will be a maintenance issue in the future since it must be renewed periodically. Recommend that a qualified contractor repair where necessary and per standard building practices. For example, by removing sealant and installing flashing.

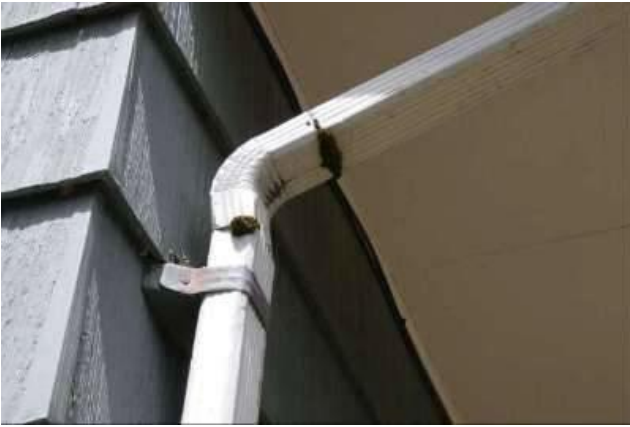
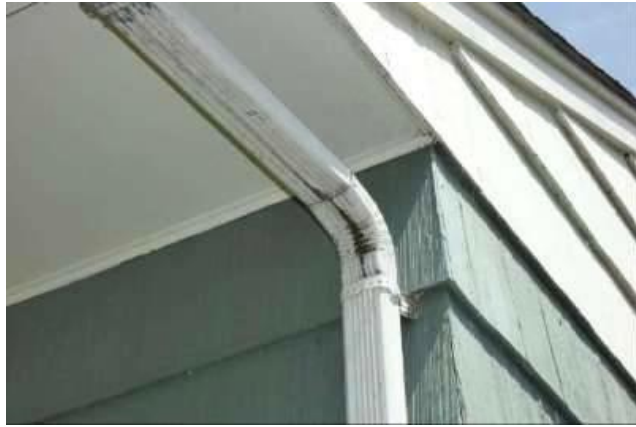
59) Downspouts had evidence of prior leakage. Rainwater can come in contact with the building exterior or accumulate around the building foundation as a result. This is a conducive condition for wood-destroying organisms. Recommend that a qualified person repair as necessary.

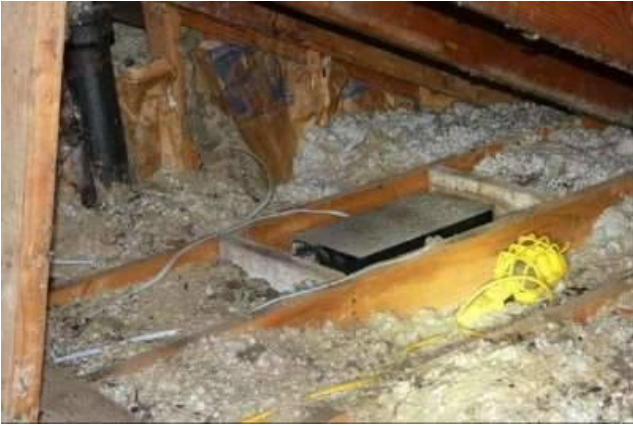
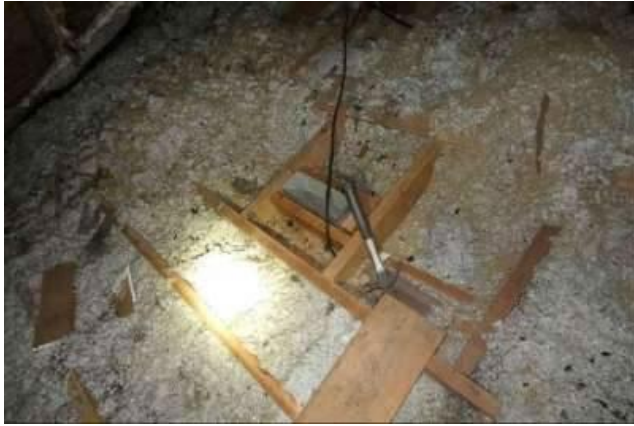
71) 🔧🔍 The exhaust fans in the attic had no duct to route the exhaust air outside. As a result, conditioned air will enter the attic when the fan is operated. This can result in excessive moisture in the attic. Recommend that a qualified contractor install ducting per standard building practices. Typically, this includes a duct with R-4 rated insulation permanently attached to a vent hood or cap installed on the roof or at an exterior wall.

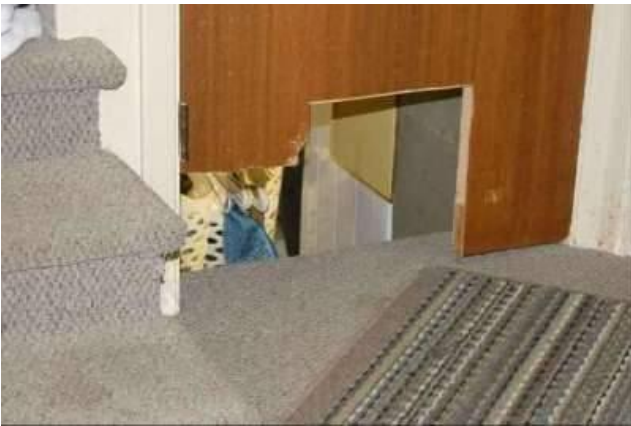
Photo 77-1

77) + The door between the garage and the house was damaged or deteriorated, and did not appear to be fire-resistant. This is a potential safety hazard. House to garage doors, to prevent fire and fumes from spreading from the garage into interior living space, should be constructed of fire-resistant materials. Doors, generally considered to be suitable for the purpose, are solid core wood, steel, honeycomb steel or a door that has been factory labeled as fire rated. Recommend that a qualified contractor replace or repair the door and, at that time, make any other corrections that might be required to provide suitable fire resistance between the garage and the dwelling per standard building practices. For more information, visit: <http://www.reporthost.com/?AGFR>

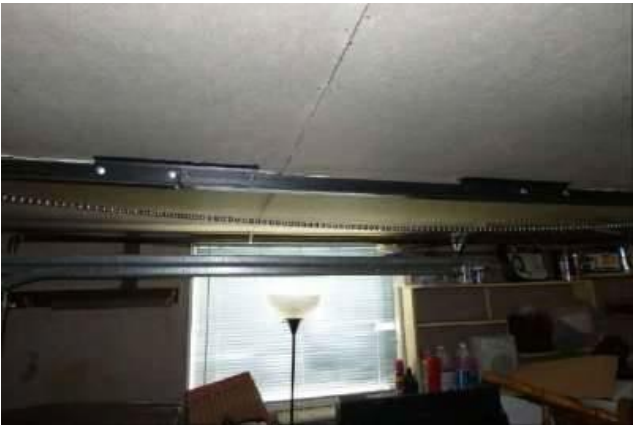
Photo 82-1

The chain on the automatic garage door opener had more slack or sag than the manufacturer recommends. Adjustment to the chain tension is encouraged.

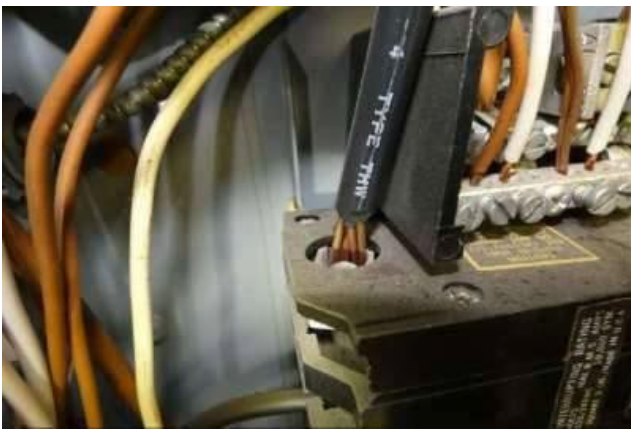
The service conductor wires appeared to be rated for less amperage than other service components (e.g. meter base, main disconnect and main service panel). This can result in the service conductor wires being overloaded. This is a potential fire hazard. Recommend that a qualified electrician evaluate and repair if necessary.

Photo 87-1 4 AWG THW copper wire has a maximum ampacity of 85 amps and is currently connected to a 100 amp main disconnect.

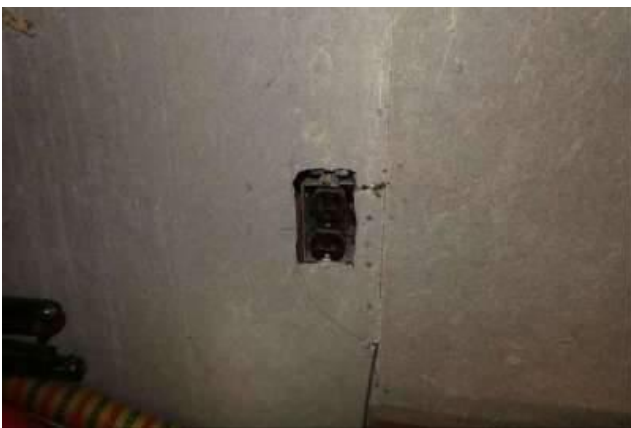
Photo 88-1

A few cover plates for switches, receptacles or junction boxes were missing or broken. These plates are intended to contain fire and prevent electric shock from occurring due to exposed wires. Recommend that a qualified person install cover plates where necessary.

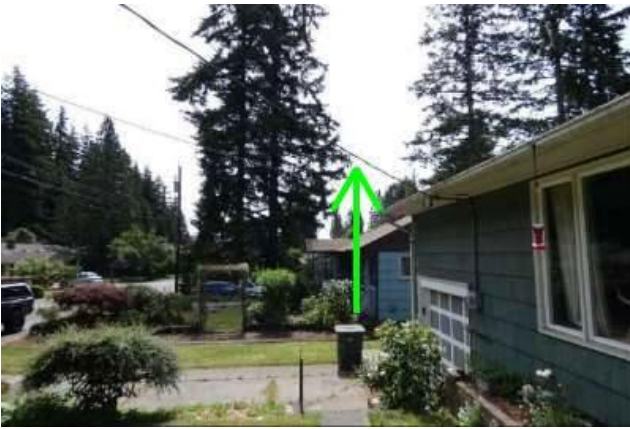
**Photo 95-1**

95) + 🔍 The service drop wires were less than 10 feet above the ground, a deck or walkways. This is a shock hazard. A qualified electrician or the utility company should repair per standard building practices.

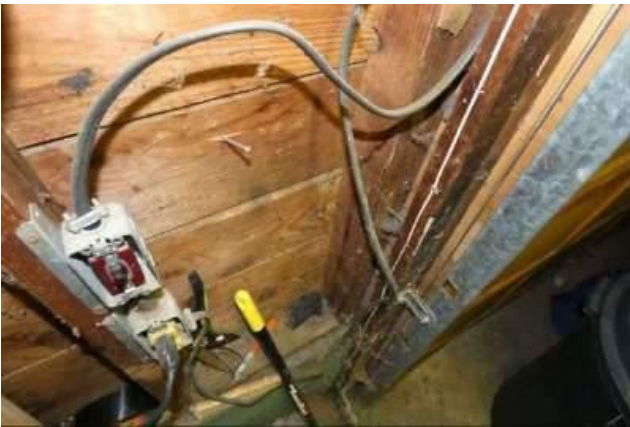
**Photo 96-1**

96) + Non-metallic sheathed wiring was loose, unsupported, or inadequately supported at a couple locations. Such wiring should be trimmed to length if necessary and attached to runners or to solid backing with fasteners at intervals of 4 1/2 feet or less. Fasteners should be installed within 12 inches of all enclosures. Recommend that a qualified electrician repair per standard building practices.

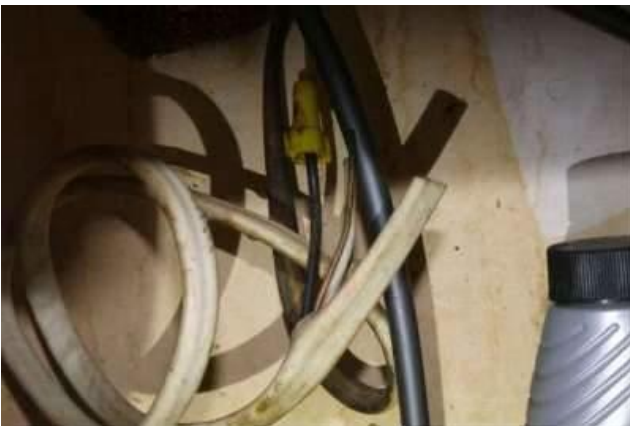
**Photo 97-1**

97) + Bare wire ends, or wires with a substandard termination, was found under the kitchen sink. This is a potential shock hazard. Recommend that a qualified electrician repair as necessary. For example, by cutting wires to length and terminating with wire nuts in a permanently mounted, covered junction box.

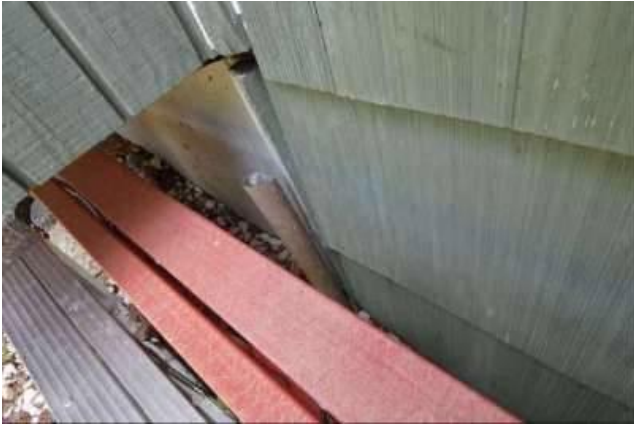
Photo 114-1 Possible vent or filling pipe located near where the line exit the crawl space.

- That any non-decommissioned, abandoned underground tanks be legally decommissioned or removed as necessary
- That the soil be tested for oil contamination
- That contaminated soil be removed as necessary

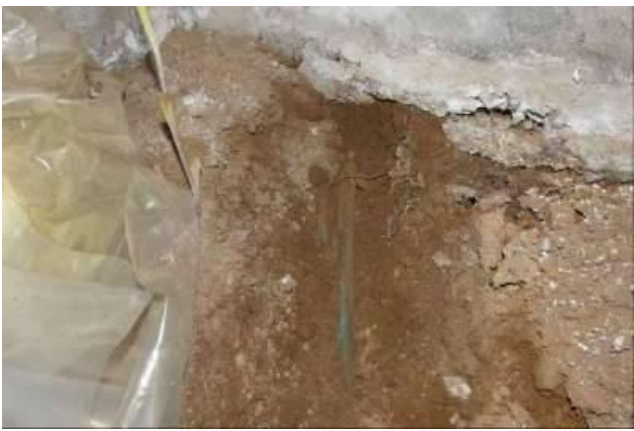
Photo 114-3 Fuel lines leading under the foundation.

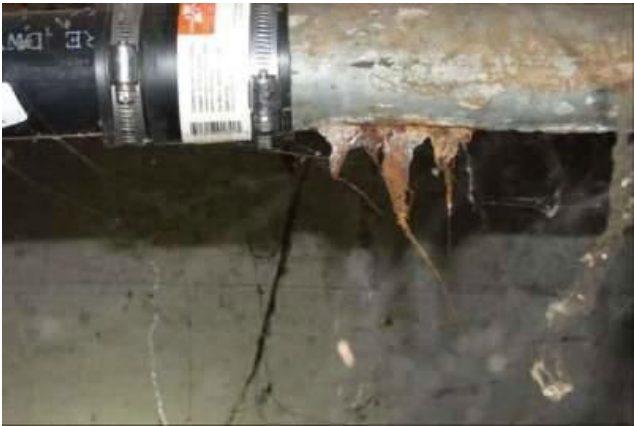
Photo 115-1

115) 🔧🔍 One leak was found in a drain pipe or fitting. A qualified plumber should evaluate and repair as necessary.

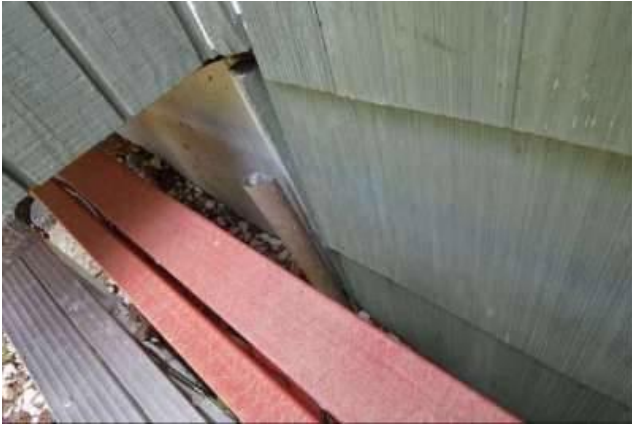
**Photo 117-1**

117) 🔧 Steel piping for the gas service located outside was corroded. Gas leaks can result. Recommend evaluation by a qualified contractor to determine if piping needs replacing. If not, then a qualified person should prep and paint lines as necessary with a rust-preventative paint. Very corroded pipes should be replaced by a qualified contractor.

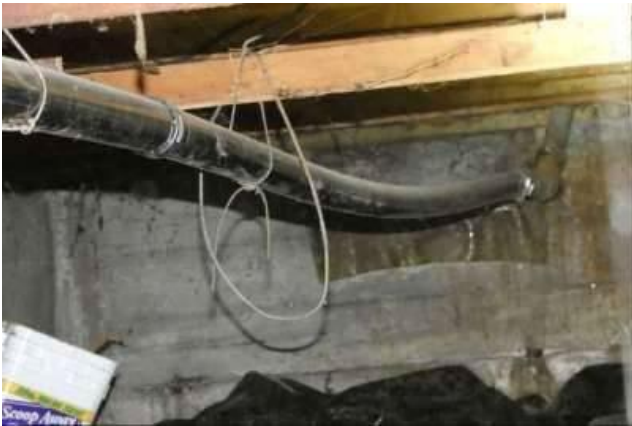
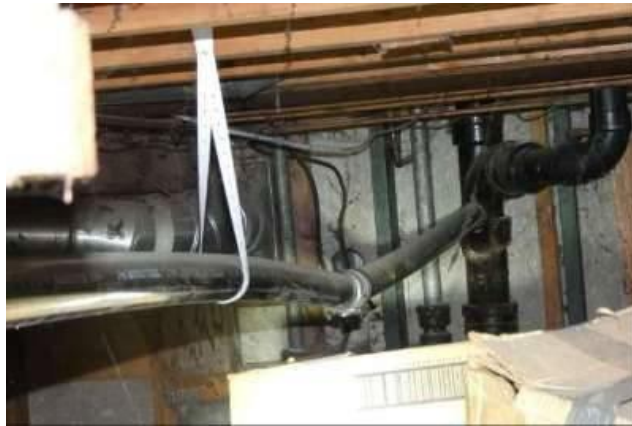
119) One drain pipe had a substandard slope. Clogging or leaks can occur as a result. Drain and waste pipes should be sloped 1/4 inch per foot of length if less than 3 inches in diameter, or 1/8 inch per foot of length for larger diameters. Recommend that a qualified plumber repair per standard building practices.

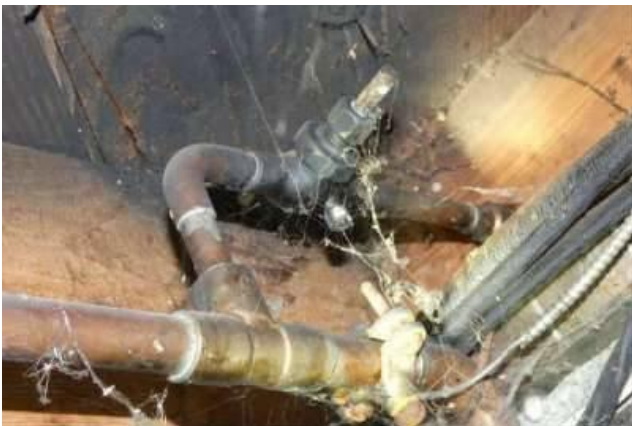
120) The handle at one water shut-off valve was missing. Recommend that a qualified person repair or replace as necessary.

**Photo 120-1** Northeast corner of the crawl space.

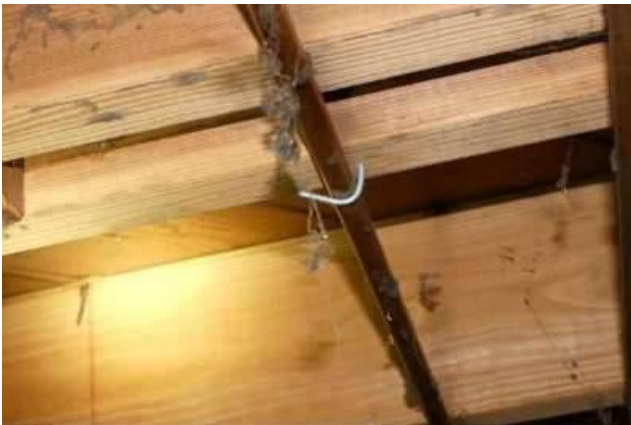
Photo 123-1

Steel hangers were used to support copper water supply pipes. Contact between such dissimilar metals causes corrosion. Recommend that a qualified plumber evaluate water supply pipes where these hangers have been used and repair or replace pipes if necessary. Recommend replacing steel hangers with approved hangers that won't cause corrosion.

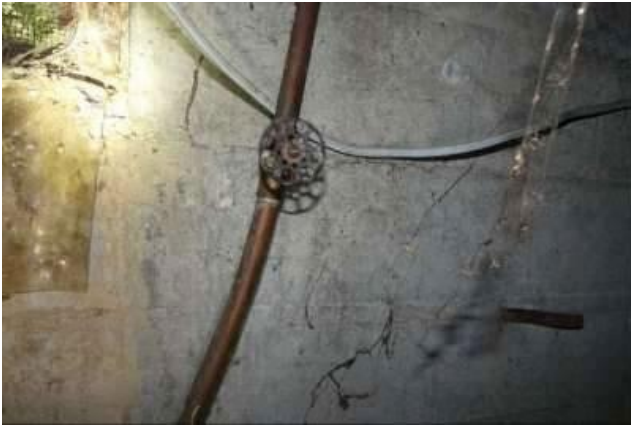
What appeared to be the main water shut-off valve was located in the crawl space. This is an inconvenient location at best, and may prevent the water from being turned off in a timely manner in the event of a plumbing emergency. Consider having a qualified plumber relocate the shut-off valve to a more convenient location, such as in a closet or a cabinet under a sink.

Photo 125-1 Located in the northeast area of the crawl space.

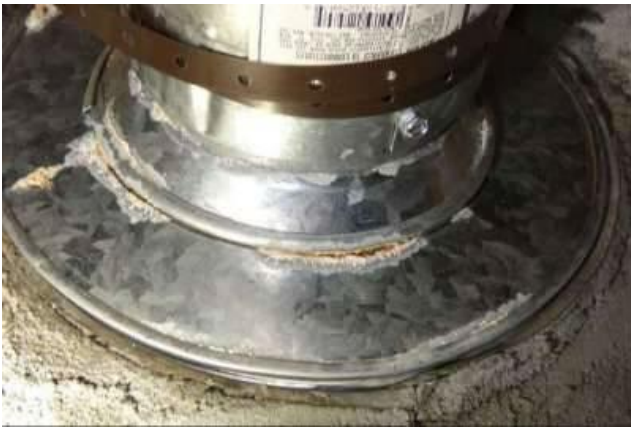
Photo 139-1

139) + 🔧 One flue pipe section or connection was slightly corroded. This is a potential safety hazard due to the risk of exhaust gases entering living spaces. A qualified person should repair per standard building practices.

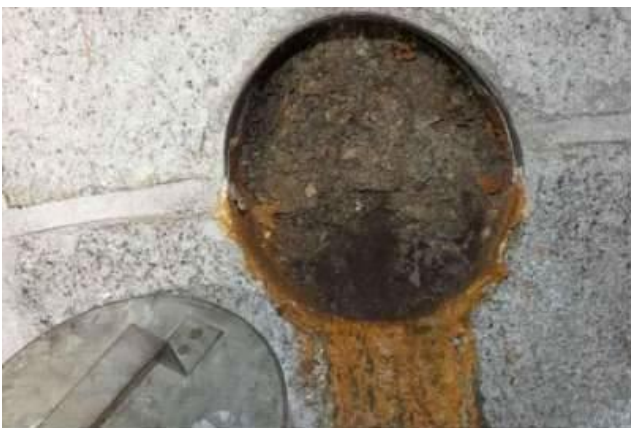
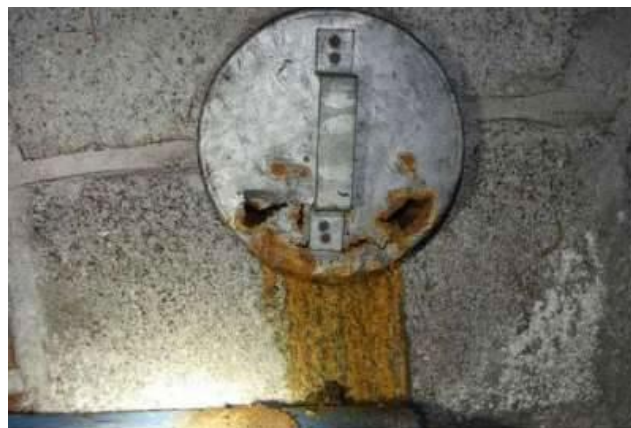
144) + One hole, gap or opening was found in the masonry chimney inside the building. This is a potential safety hazard due to the risk of exhaust gases entering living spaces. Recommend that a qualified person make permanent repairs as necessary. For example, by filling holes with masonry products such as mortar, concrete and/or bricks.

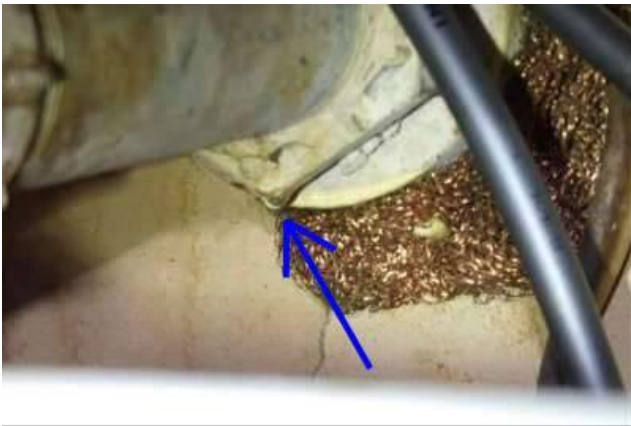
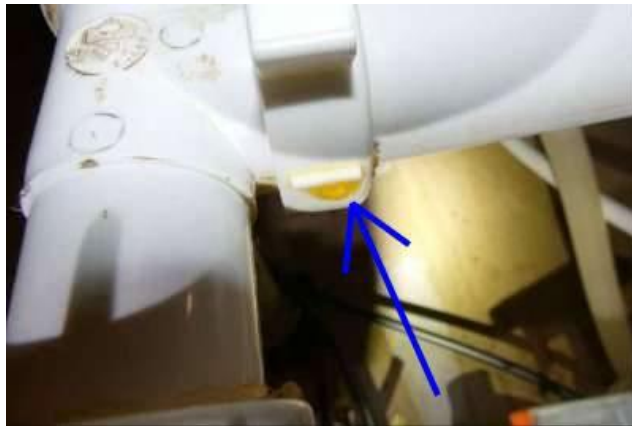
The sink drain was leaking in a couple places. A qualified plumber should repair as necessary.

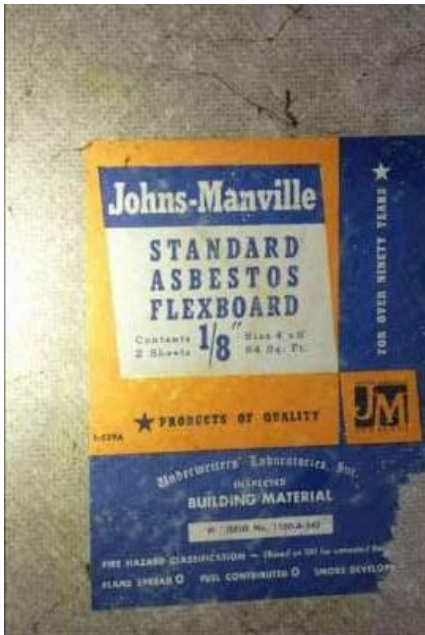
Photo 165-1 Possible asbestos containing material. Further testing may be needed to confirm, ;)

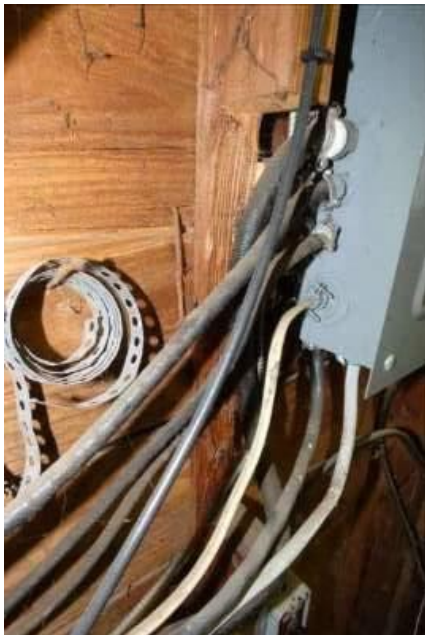
A couple notches were wider than 25% of the stud depth in bearing wall. This is substandard construction and has damaged the stud. Recommend that a qualified contractor evaluate and repair as necessary.

Photo 166-1 Northeast section of the garage.

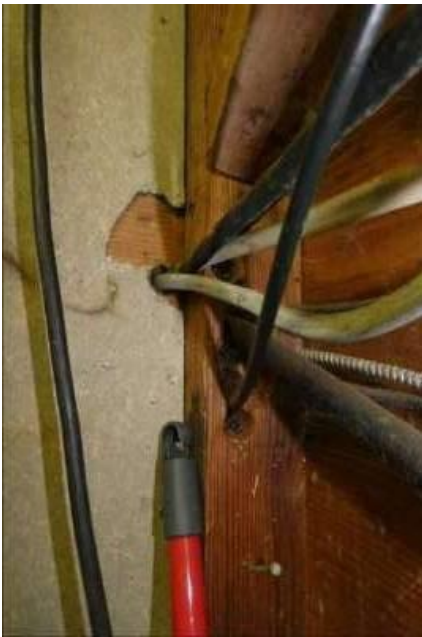
Multiple holes were bored less than 5/8 inch from the edge of a stud. Standard building practices require that the edges of bored holes be at least 5/8 inch from the edges of studs. Recommend that a qualified contractor evaluate and repair as necessary.

Photo 167-1 Northeast section of the garage.

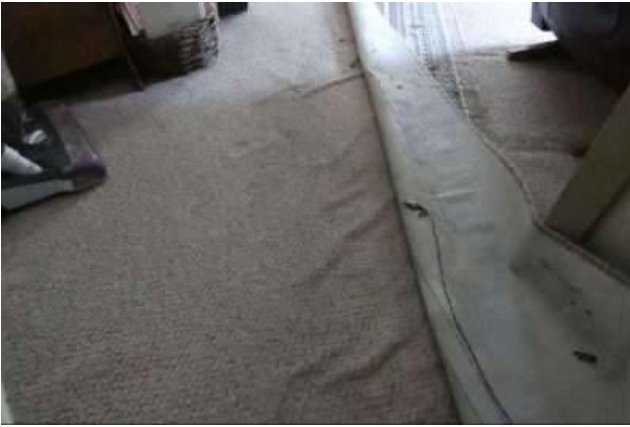
Photo 176-1

Carpeting in some areas was loose. Recommend that a qualified contractor repair as necessary. For example, by stretching or replacing carpeting.

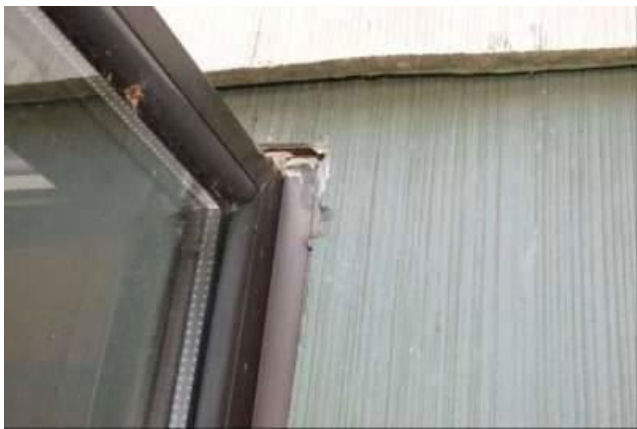
187) 🔍 The window box in the kitchen was installed using substandard methods. Elevated moisture levels were present at time of inspection. Recommend further evaluation and repair or replace as necessary by qualified contractor.

Photo 187-1 Missing caulking

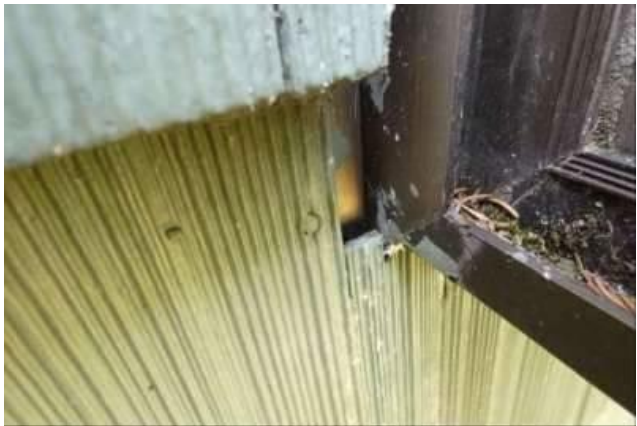
Photo 187-3 Missing flashing

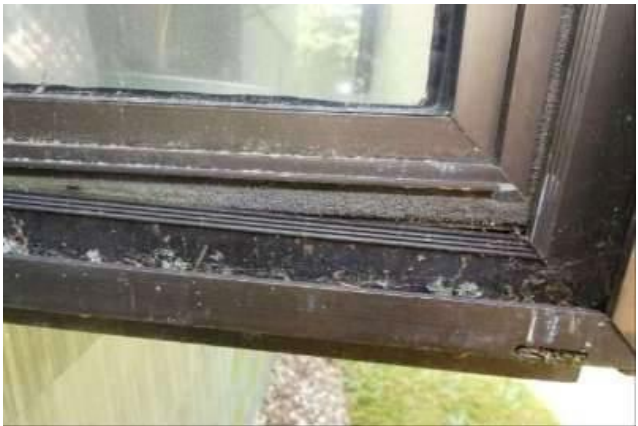
Photo 187-4 Window was not making a complete seal.

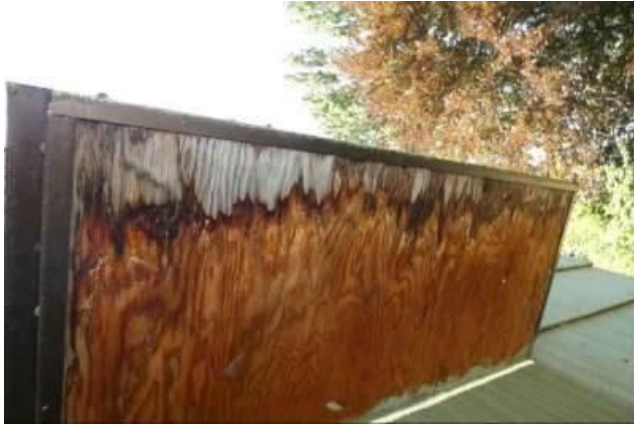
**Photo 188-2** Pneumatic closer had broken off.
