Baker Home Inspections

Client(s): **Sample Report**

Property address: **123 Anonymous St
Bellingham WA**

Inspection date: **Wednesday, January 9, 2019**

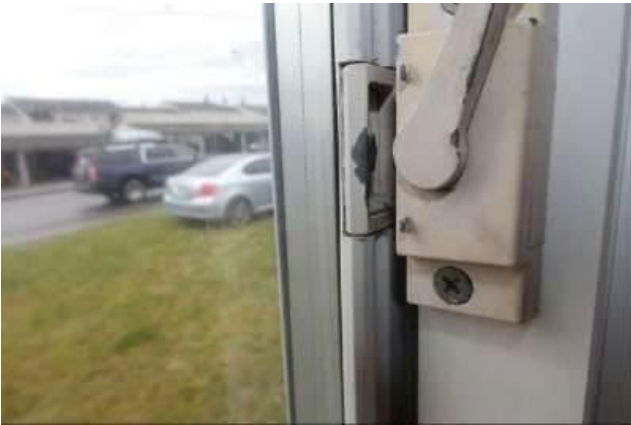
Photo 103-1

-
- 100)** 🛠️ Weatherstripping around the exterior doors was deteriorated. Water may enter the building, or energy efficiency may be reduced. Recommend that a qualified person repair or replace weatherstripping as necessary.
-
- 101)** 🛠️ Metal threshold at the front exterior door was substandard. Recommend that a qualified person repair as necessary to minimize sagging or movement, to ensure that the threshold is securely attached, and apply caulk or weather stripping materials to make a weatherproof seal.
-
- 102)** 🛠️ The lock mechanism on the sliding glass door was inoperable. Recommend that a qualified person repair as necessary.
-
- 103)** 🛠️ Lock mechanisms on a couple windows were damaged. This can pose a security risk. Recommend that a qualified person repair as necessary.
-

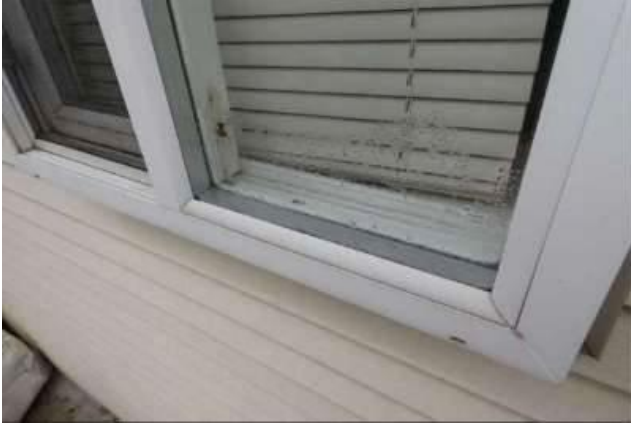
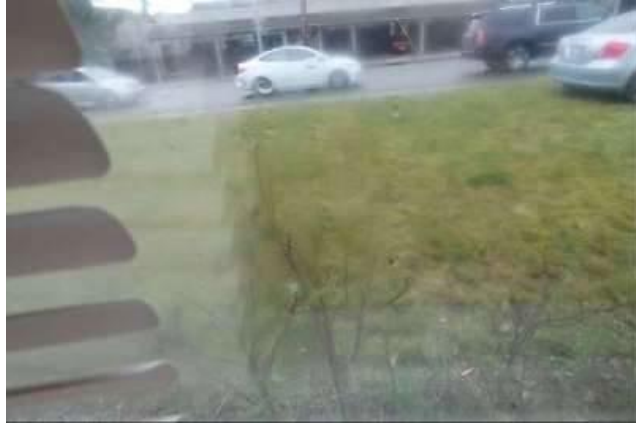
Photo 108-1

Be aware that evidence of failed seals or desiccant may be more or less visible depending on the temperature, humidity, sunlight, etc. Windows or glass-paneled doors other than those that the inspector identified may also have failed seals and need glass replaced. It is beyond the scope of this inspection to

identify every window with failed seals or desiccant.
