Baker Home Inspections

Client(s): **Future Home Owner**
Property address: **123 Baker Street**
Bellingham, WA
Inspection date: **Thursday, December 13, 2018**

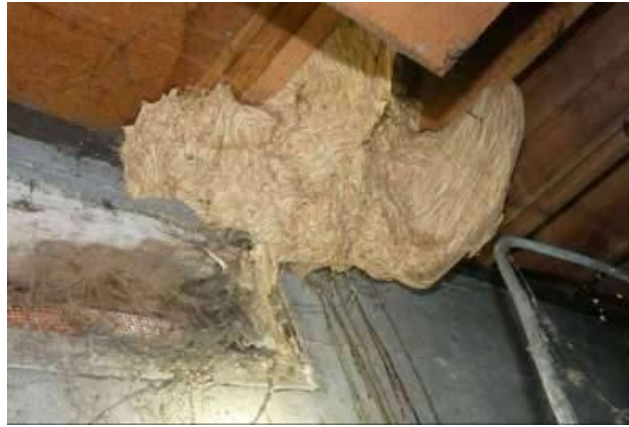
Photo 1-2

A few hornet, bee or wasp nests were found at the building exterior and in the crawl space. These can pose a safety hazard. A qualified person should remove nests or exterminate as necessary.

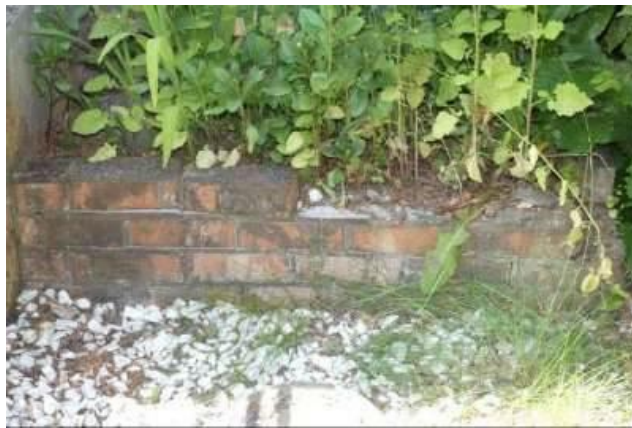
Photo 10-2

- 10) **⚠** The masonry planters were damaged and/or deteriorated. Recommend that a qualified person remove, repair or replace planters as necessary.

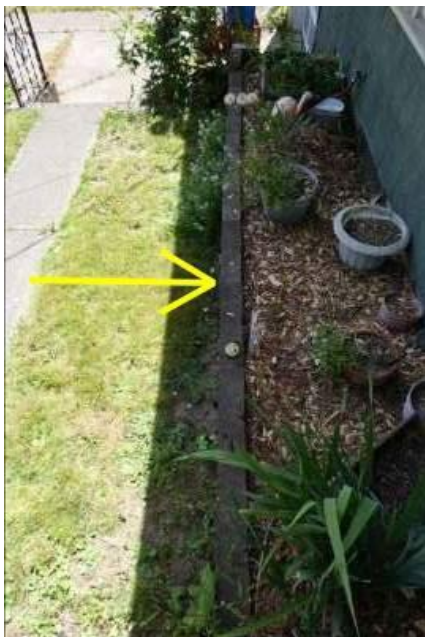
Photo 10-3 Bowing in the middle

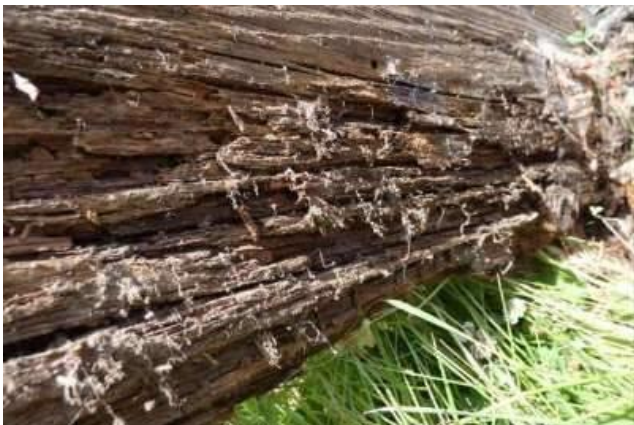
Photo 11-2

Fungal rot or damage from wood-destroying insects was found at the wooden planter boxes. Recommend that a qualified person remove, repair or replace planter boxes as necessary. All rotten or insect-damaged wood should be replaced or removed.

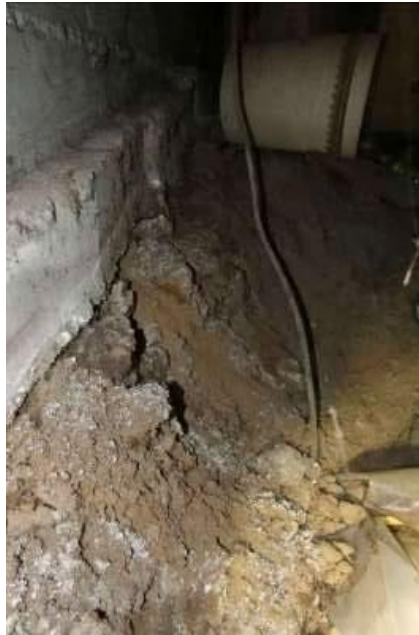
19) A couple isolated footings or sections of footings or foundations were undermined. Soil has either eroded out from underneath or has been excavated too close to these areas. Standard building practices typically require undisturbed soil to extend at least a foot horizontally out from the edge of footings and then slope down no more steeply than 45 degrees. Otherwise soil can collapse from beneath the footing(s). Recommend that a qualified contractor or engineer evaluate and determine what repairs if any should be made. If repairs are needed, a qualified contractor should make them.

Photo 19-2 Southwest corner of crawl space.

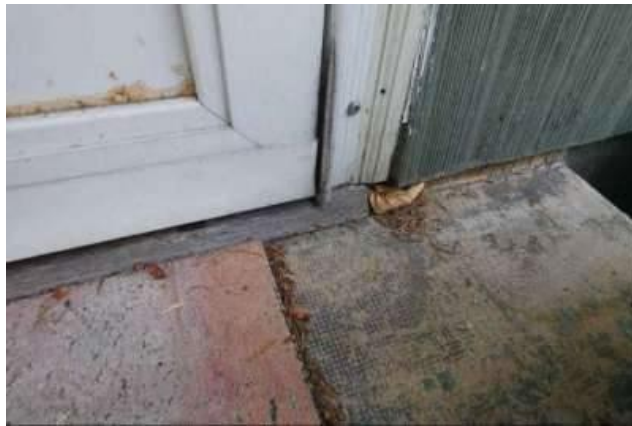
Photo 20-2

Untreated wood siding and/or trim was in contact with concrete or masonry at the exterior. Moisture collected between the two materials or wicking up into the wood is a conducive condition for wood-destroying organisms. Wood siding or trim should be installed with a minimum clearance of 1-2 inches between it and concrete or masonry below it at building exteriors. Monitor these areas for rot or infestation in the future and repair if needed. Recommend that a qualified person repair per standard building practices. For example, by trimming siding or trim as needed.

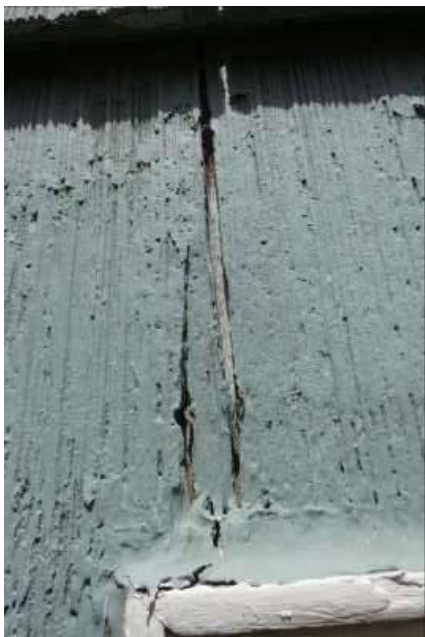
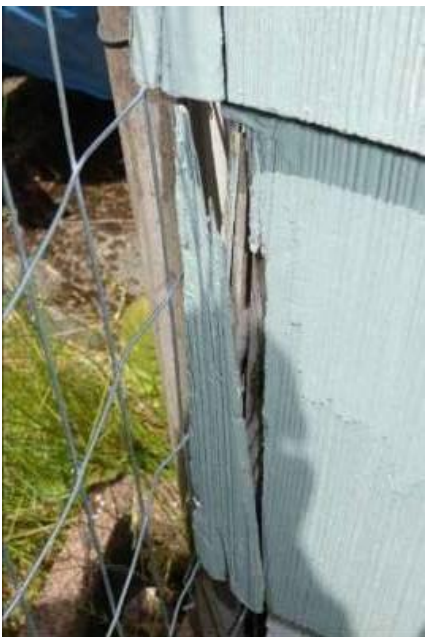
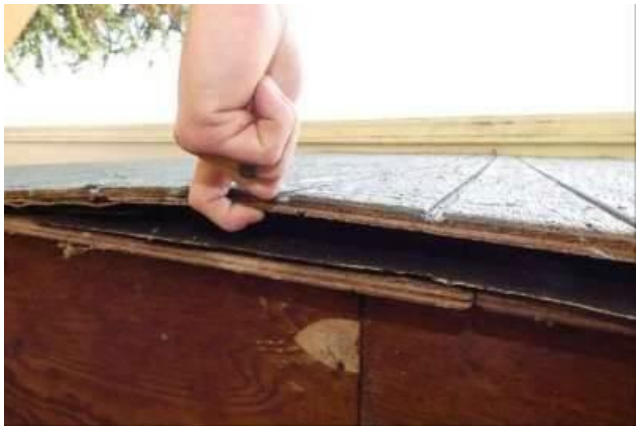
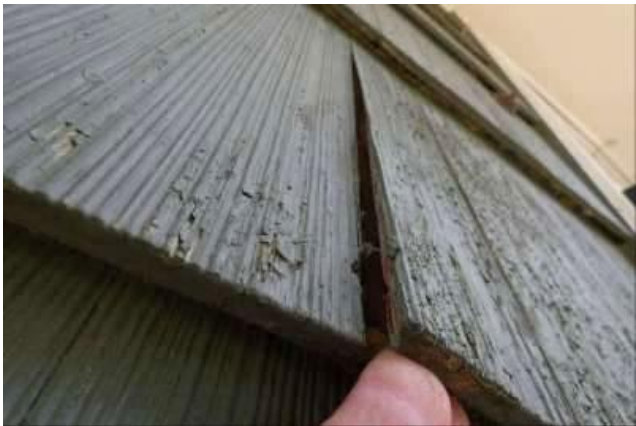
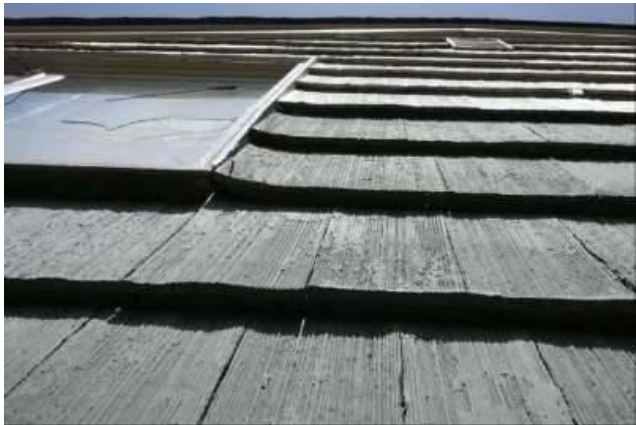
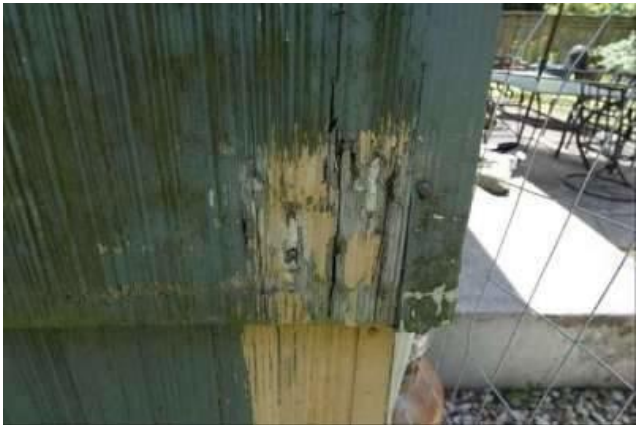
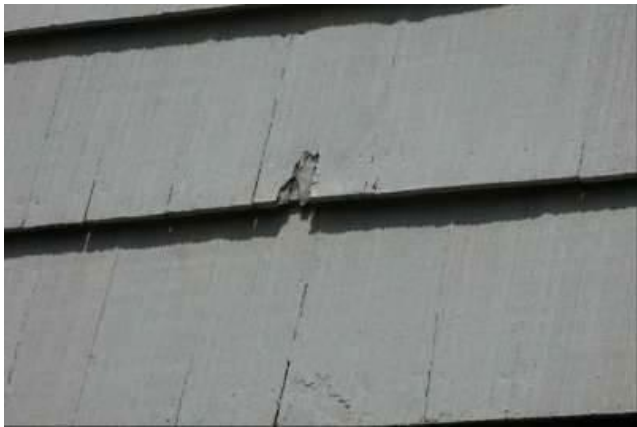
Many sections of siding and/or trim were deteriorated, split, warped, damaged, and/or substandard. Recommend that a qualified person repair, replace or install siding or trim as necessary.

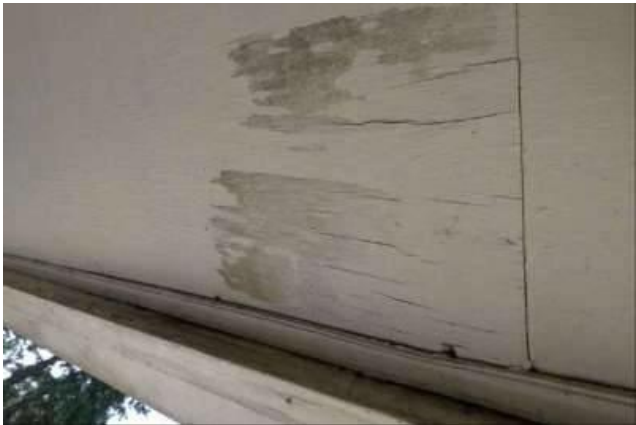
23) 🪛 Fungal rot was found at sections of siding, trim, window sills, fascia and, barge boards. Conductive conditions for rot should be corrected. Recommend that a qualified contractor repair as necessary. All rotten wood should be replaced.

Photo 23-2 Soffit above front entrance.

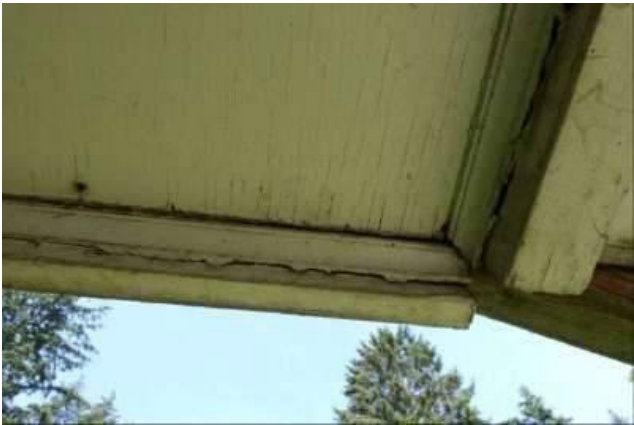
Photo 23-9 Northeast corner soffit

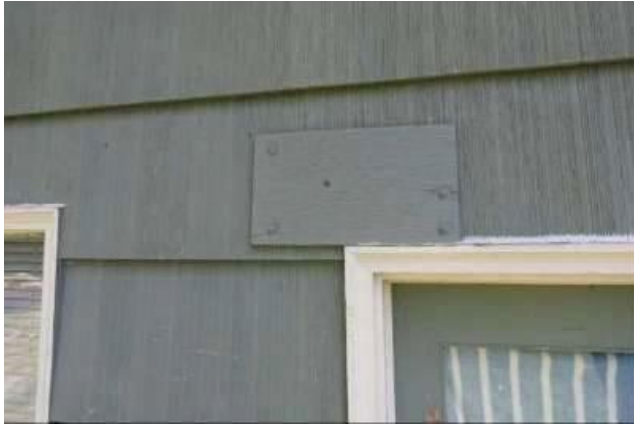
Photo 26-2

A few holes or gaps were found in siding or trim. Vermin, insects or water may enter the structure. Recommend that a qualified person repair as necessary.

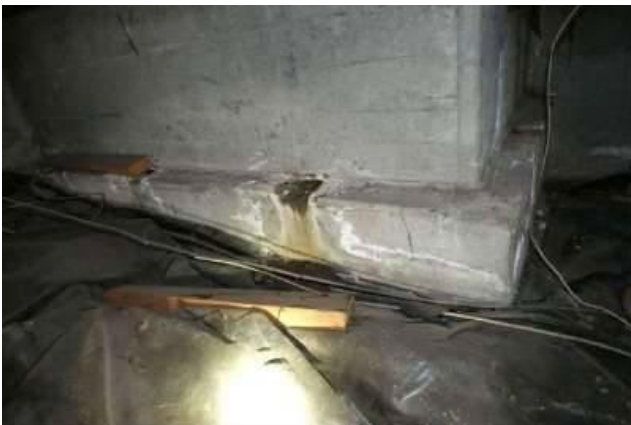
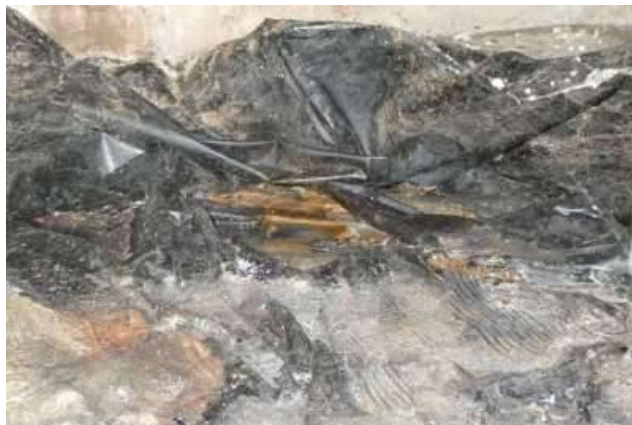
Ideally, water should not enter crawl spaces, but if water must be controlled after it enters the crawl space, then typical repairs include installing trenches, gravity drains and/or sump pump(s) in the crawl space.

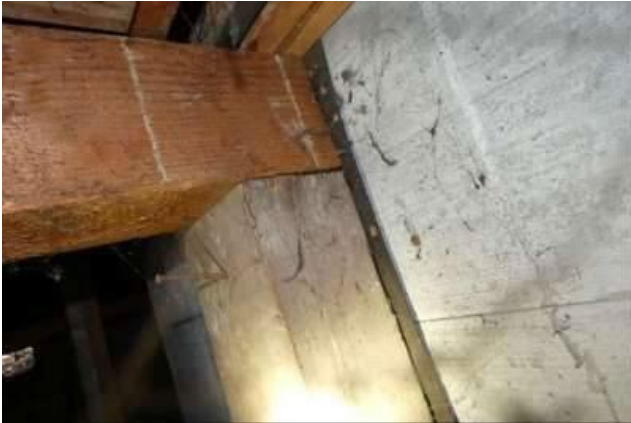
Photo 45-1

Support posts were not positively secured on both sides to the beam above. While this is common in older homes, current standards require positive connections between support posts and beams above for earthquake reinforcement. Recommend that a qualified contractor evaluate and repair per standard building practices. For example, by installing metal plates, plywood gussets or dimensional lumber connecting posts and beams.

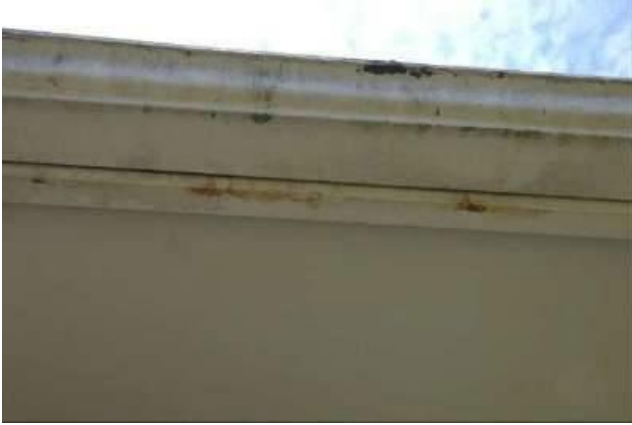
Photo 47-1

Water stains were found behind a couple gutters. Rainwater can come in contact with the building exterior or accumulate around the foundation as a result. The edge of the roof structure may become damaged by rot or water. This is a conducive condition for wood-destroying organisms.

Recommend that a qualified person evaluate and repair as necessary. For example, by installing flashing or tightening loose gutters.

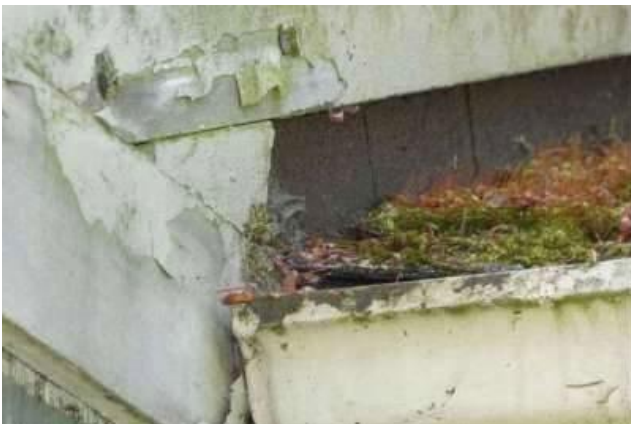
Photo 52-1

52) Kick-out flashing was missing at the northeast corner. Such flashing should be located at the bottom of slopes where roof surfaces intersect with exterior walls above. It directs rainwater away from exterior walls and into gutters so that rainwater is less likely to run down the front surfaces of siding or flow behind siding. Recommend that a qualified contractor install kickout flashings where missing and per standard building practices.

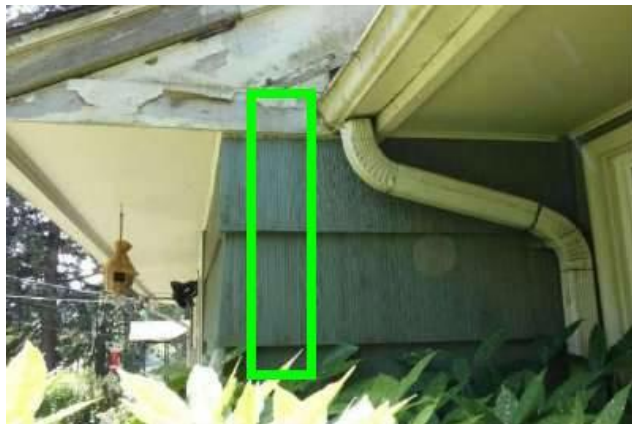
Photo 52-2 Rain water had been running down the siding and caused rot.

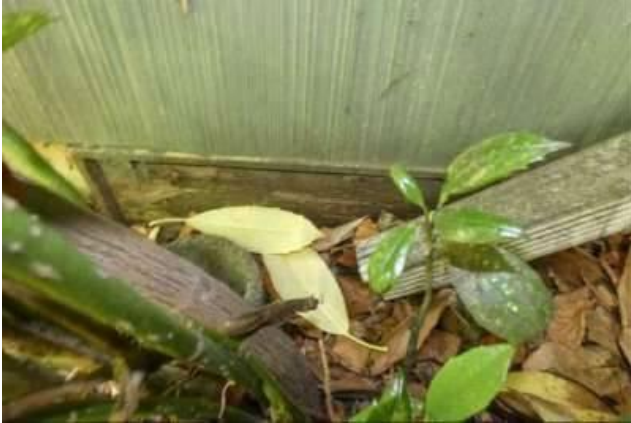
57) Extensions such as splash blocks or drain pipes for a couple downspouts were missing. Water can accumulate around the building foundation or inside crawl spaces or basements as a result. Recommend that a qualified person install, replace or repair extensions as necessary so rainwater drains away from the structure.

Photo 57-1 Downspout terminates next to crawl space vent.

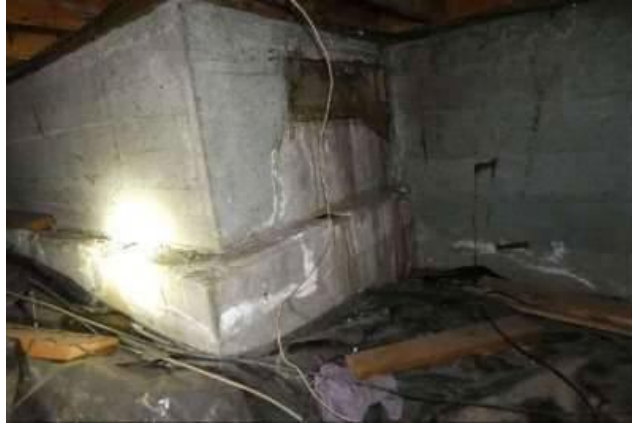
Photo 57-2 Evidence of water entering crawl space through vent.

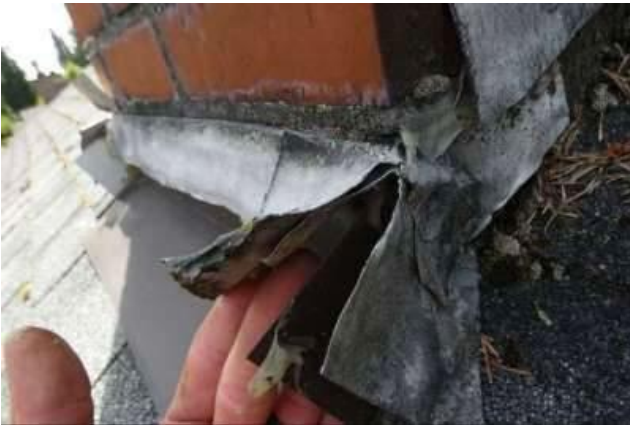
Photo 62-1

62) Flashings at the base of the chimney were loose and/or substandard. Leaks can occur as a result. This is a conducive condition for wood-destroying organisms. Recommend that a qualified contractor evaluate and repair as necessary.

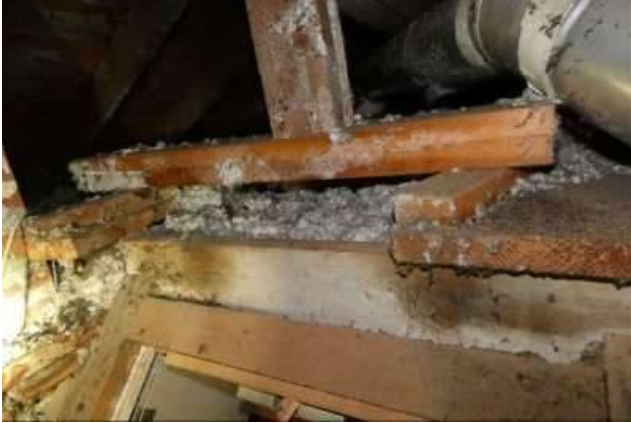
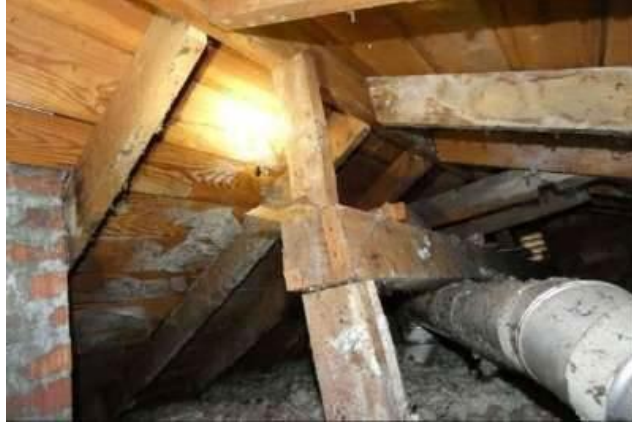
65) + Substandard construction methods observed in the attic. This is a potential safety hazard. Recommend further evaluation and repair or replace as necessary by qualified contractor.

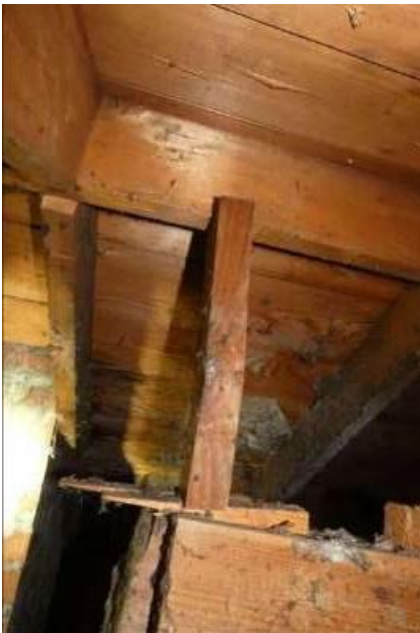
Photo 65-3 Oh, good, they shimmed it.

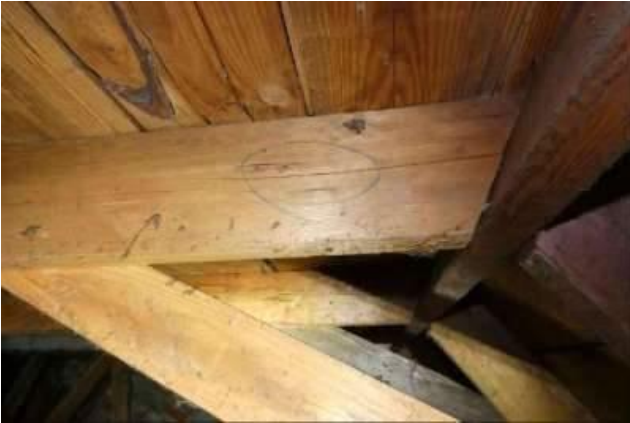
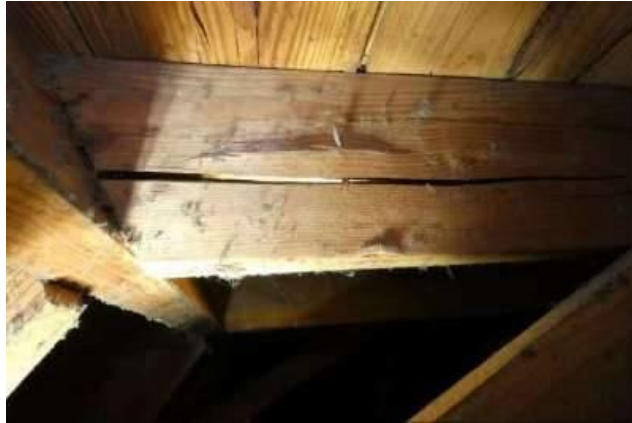
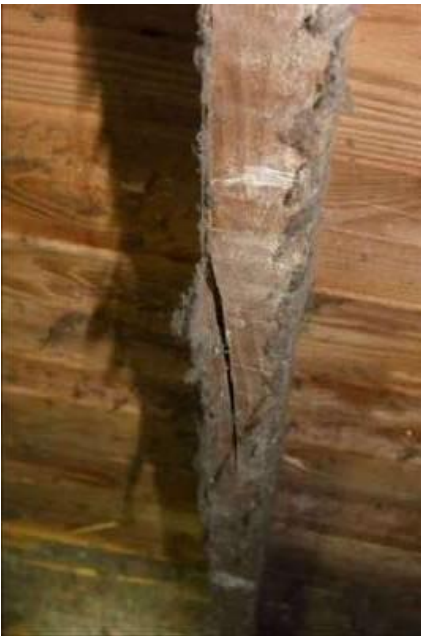
68) 🔧🔍 A few rafters in the roof structure were damaged or split. This may weaken the roof structure. Recommend that a qualified contractor evaluate and repair or replace as necessary.

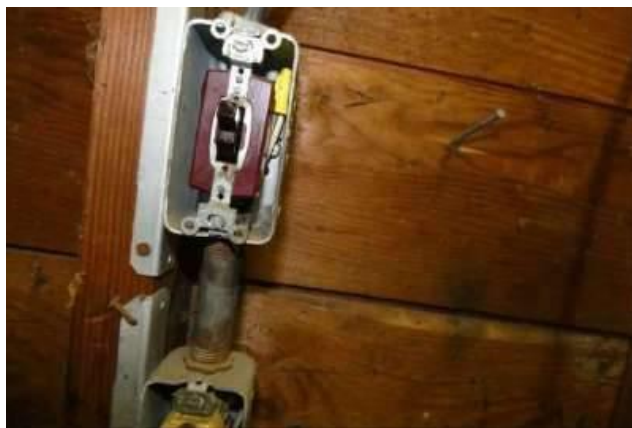
Photo 88-2

A few cover plates for switches, receptacles or junction boxes were missing or broken. These plates are intended to contain fire and prevent electric shock from occurring due to exposed wires. Recommend that a qualified person install cover plates where necessary.

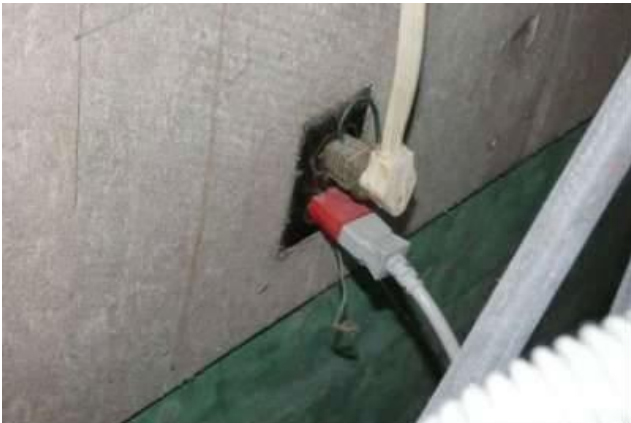
Photo 94-1

94) + 🔍 2-slot receptacles rather than 3-slot, grounded receptacles were installed in a few areas. These do not have an equipment ground and are considered unsafe by today's standards. Appliances that require a ground should not be used with 2-slot receptacles. Examples of such appliances include computers and related hardware, refrigerators, freezers, portable air conditioners, clothes washers, aquarium pumps, and electrically operated gardening tools. The client should be aware of this limitation when planning use for various rooms, such as an office. Upgrading to grounded receptacles typically requires installing new wiring from the main service panel or sub-panel to the receptacle(s), in addition to replacing the receptacle(s). Consult with a qualified electrician about upgrading to 3-wire, grounded circuits.

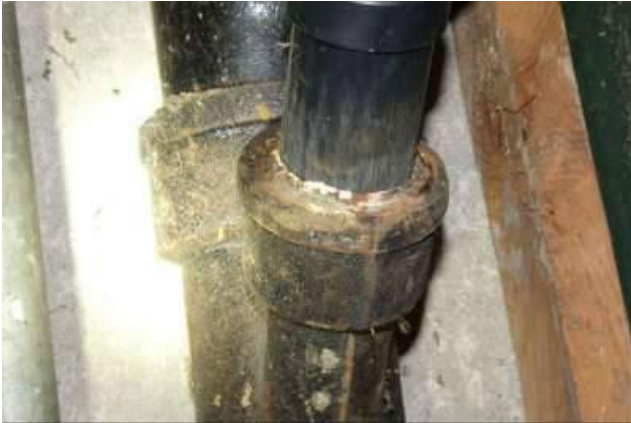
Photo 122-1

Stains were found in a couple sections of drain and/or waste lines, but no active leaks were found near the stains. This may indicate that past leaks have occurred. Consult with the property owner about this, and either monitor these areas in the future for leaks or have a qualified plumber evaluate and repair as necessary.

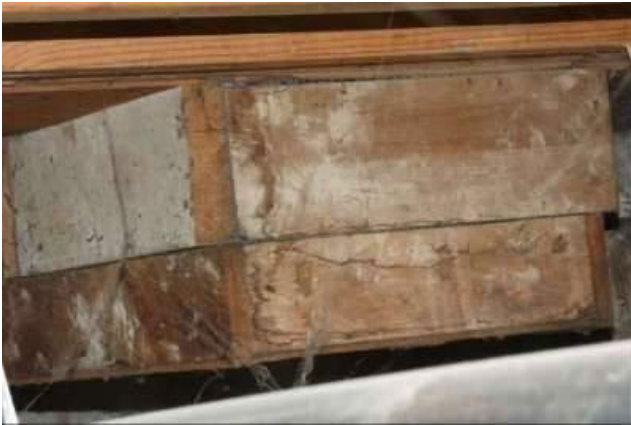
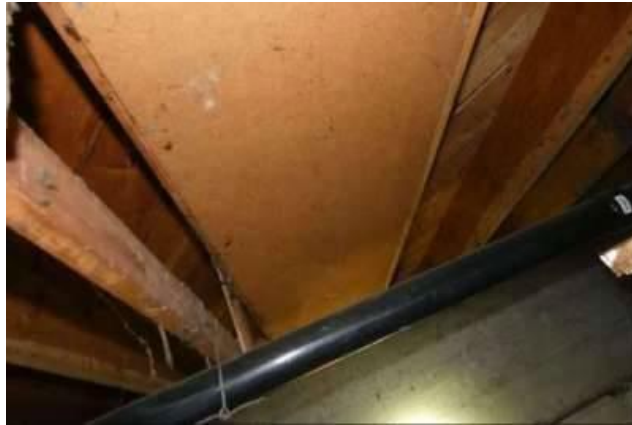
136) 🔍 Many ducts were made of wood. While this is common in older homes, microbial growths can form within the ducts when humidity levels reach 60% or higher. This is a potential safety hazard. Recommend further evaluation and repair or replace as necessary by qualified HVAC professional.

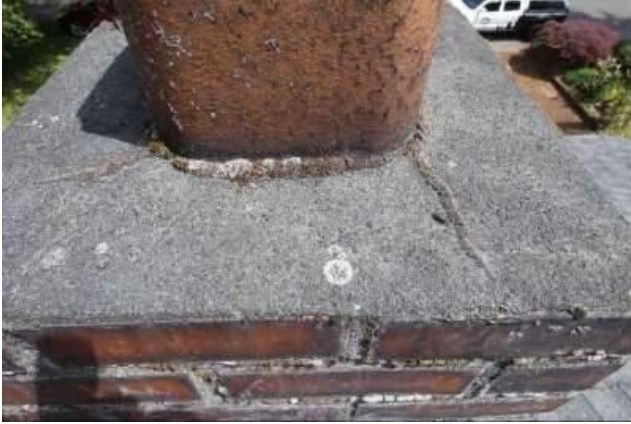
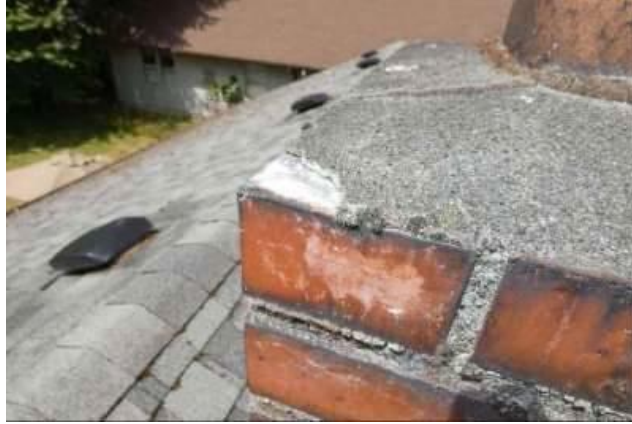
- Be constructed using either precast concrete slabs, cast-in-place steel reinforced concrete, solid stone, or metal
- Be sloped down from the flue a minimum of 3 inches of fall per foot of run
- Extend a minimum of 2 1/2 inches beyond the face of the chimney on all sides
- Not directly contact the flue liner (if installed), with the gap filled with flexible caulk
- Have flashing installed between the bottom of the crown and the top of the brick chimney

Recommend that a qualified contractor repair or replace crowns as necessary, and per standard building practices.

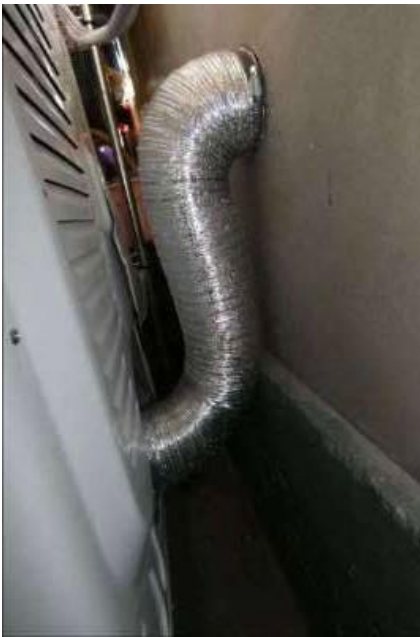
Photo 153-1

153) The clothes dryer was equipped with a vinyl or mylar, accordion-type, flexible exhaust duct. The U.S. Consumer Product Safety Commission considers these types of ducts to be unsafe, and a fire hazard. They can trap lint and are susceptible to kinks or crushing, which can greatly reduce the air flow and cause overheating. Recommend that such ducts be replaced with a rigid or corrugated semi-rigid metal duct, and by a qualified contractor if necessary. For more information, visit:

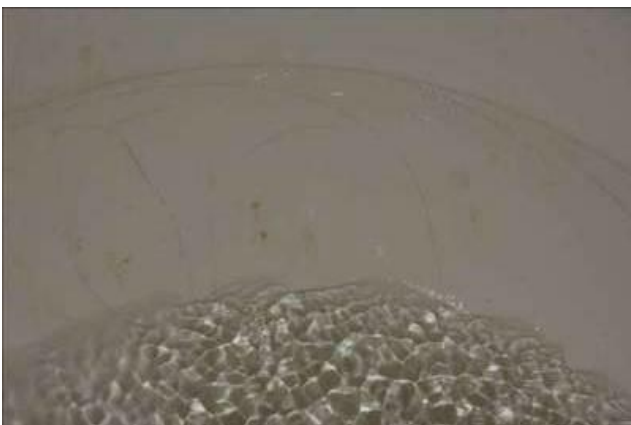
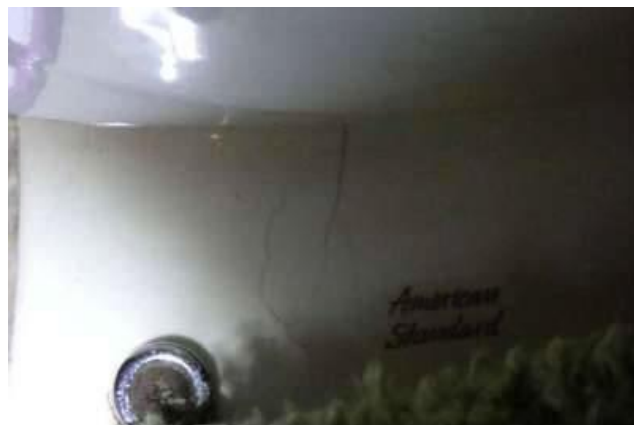
- 161)** 🛠️ The toilet had multiple hairline cracks. Recommend repair or replace as necessary by qualified plumber.

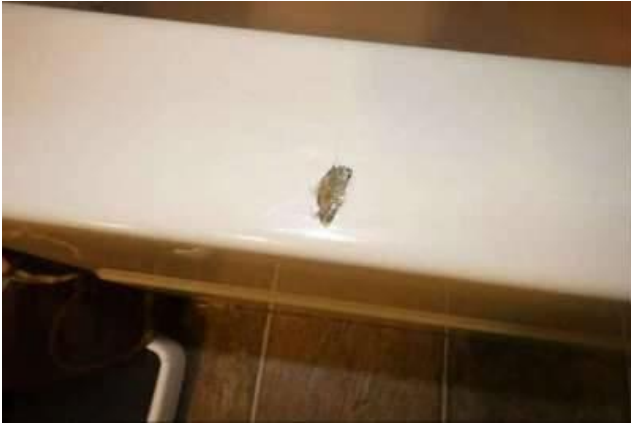
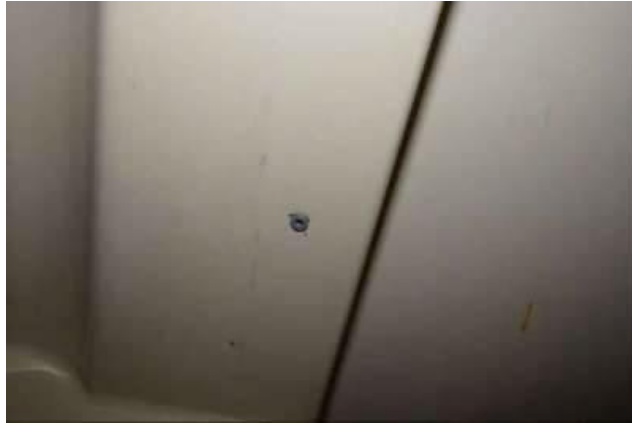
The bathtub was worn, blemished or deteriorated.

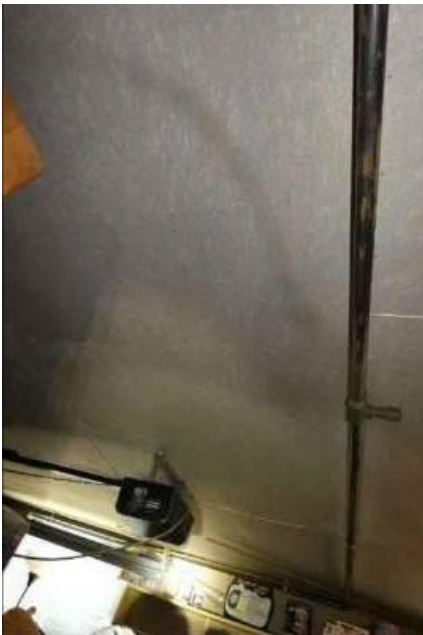
Photo 165-2 Walls and ceiling in the garage.

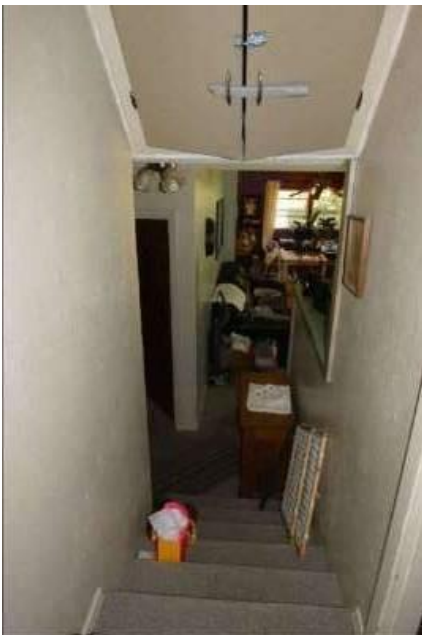
Photo 169-1

169) + The ceiling height over the stairs at one location was too low and poses a safety hazard, especially for tall people. Ceilings over stairs should be at least 6 feet 8 inches high. At a minimum, be aware of this hazard, especially when guests who are not familiar with the stairs are present. Recommend that a qualified contractor repair per standard building practices.

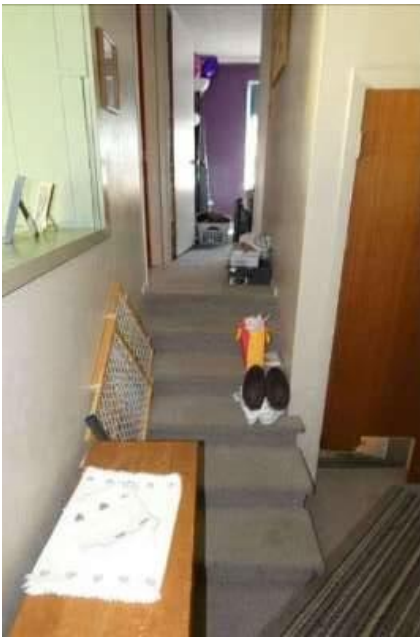
**Photo 170-1**

170) + A handrail at one flight of stairs was missing. This is a potential fall hazard. Handrails should be installed at stairs with four or more risers or where stairs are greater than 30 inches high. Recommend that a qualified contractor install handrails where missing and per standard building practices.

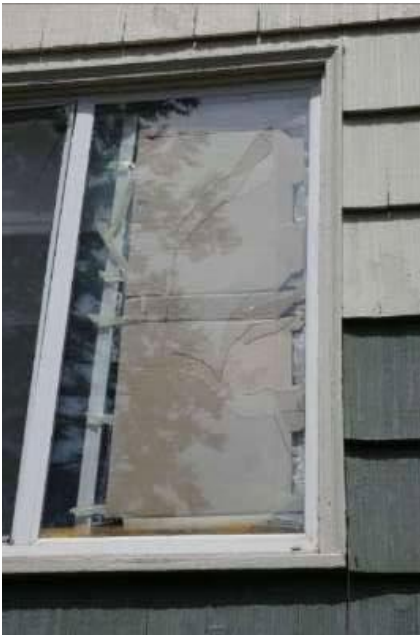
**Photo 172-1**

Glass in one window was cracked, broken and/or missing. Recommend that a qualified contractor replace glass where necessary.

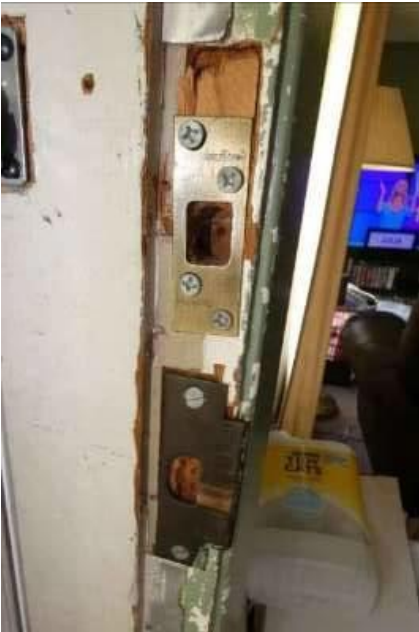
Photo 177-1

Some exterior door hardware, including locksets and/or latches were damaged and/or loose. Recommend that a qualified person repair or replace as necessary.

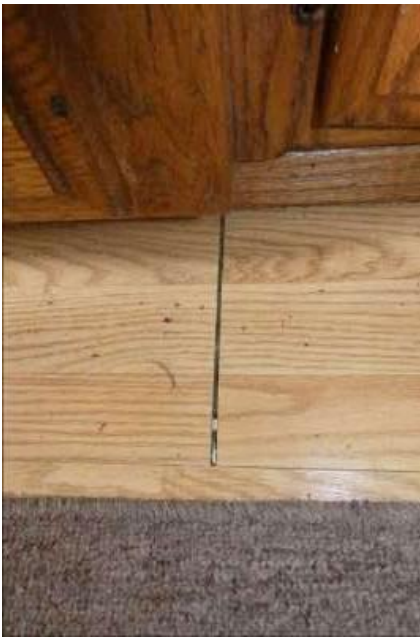
Photo 180-1

The laminate flooring in the kitchen had some gaps. This could allow spilled water to penetrate the sub-floor creating a conducive condition for wood-destroying organisms. Recommend repair by qualified contractor.

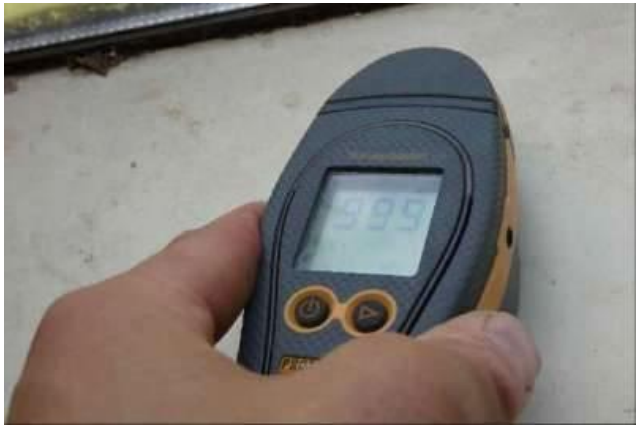
Photo 187-5 On inside of window box.

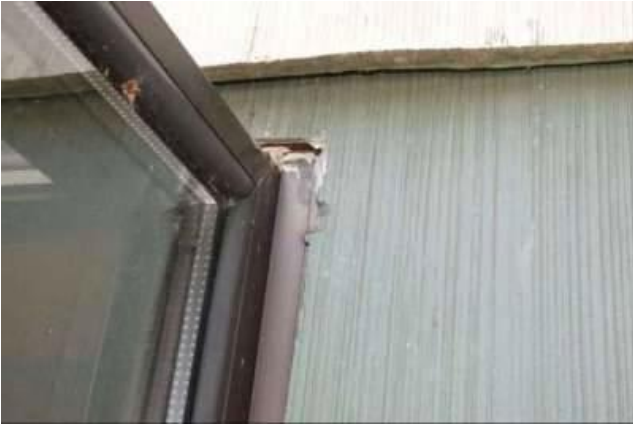
**Photo 188-1**

The storm doors were damaged, missing fasteners and components. Recommend that a qualified person evaluate and repair or replace as necessary.

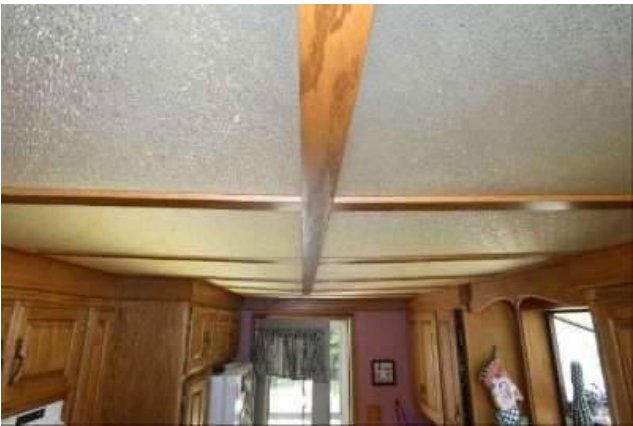
**Photo 189-1**

The drop lighting in the kitchen was sagging. Recommend further evaluation and repair or replace as necessary by qualified contractor.
